Assessment of selected active landslides in Slovakia in 2011

LUBOMÍR PETRO¹, PAVEL LIŠČÁK² and PETER ONDREJKA²

Key words: hazardous landslides, inventory, assessment

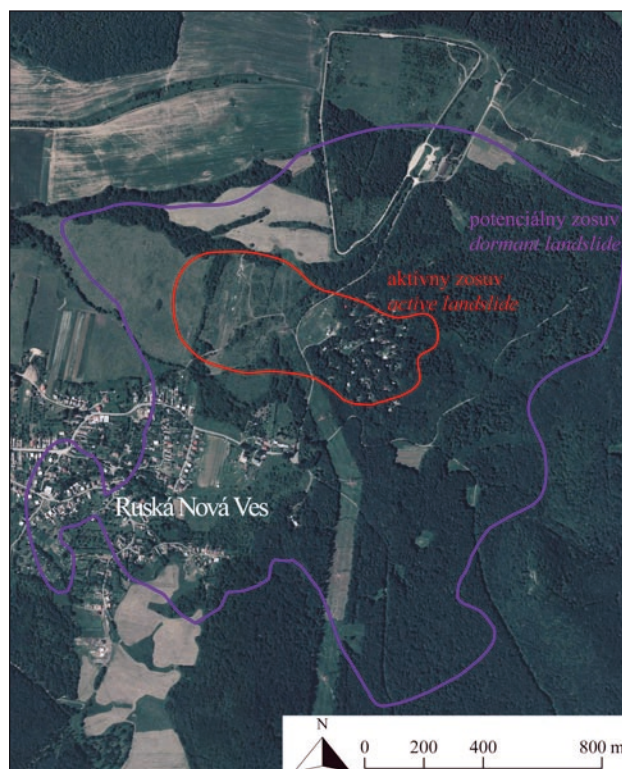
Fig. 2. Situation of landslide evolved in 2010 and re-activated in 2011, Ruská Nová Ves. The active landslide damaged 20 holiday cottages and engineering networks in the local forest-park (No. 13 in Fig. 1). December 2011.

The active landslide is located northeast of the Ruská Nová Ves Village (Fig. 2). It evolved after excessive precipitation in May and June 2010. However, it had not been reported as an emergency landslide, therefore it did not get into the MoE SR database of 2010 and was not assessed, nor its socio-economic relevance. The result of ongoing slide activity in 2011 were several residential buildings damaged along with over 20 holiday cottages, access roads, playground, engineering networks (water and electrical connections), wells, hedges, forest cover etc. In the active landslide there is also the recently built VHV mast (Very High Voltage – 400 KV – Fig. 3). The static damage of several huts has been evaluated as serious

The measures to stabilize the sliding slope were designed in the scope of the site assessment drawn up by the end of 2011 (Spišák et al., 2011) and they included:

- removal of artificial small lake situated within the landslide body at one of the holiday cottages;
- elimination of infiltration of water from roofs and paved areas into basement, realized through a conduction of the water tapped into the erosion gullies at the edge of the landslide body;
- cleaning up the deeper erosion gullies in order to ensure the drainage of surface water;
- adjustment of slope in the main scarp area of the active landslide, i.e. the backfill of open fractures and alleviation of the slope angle.

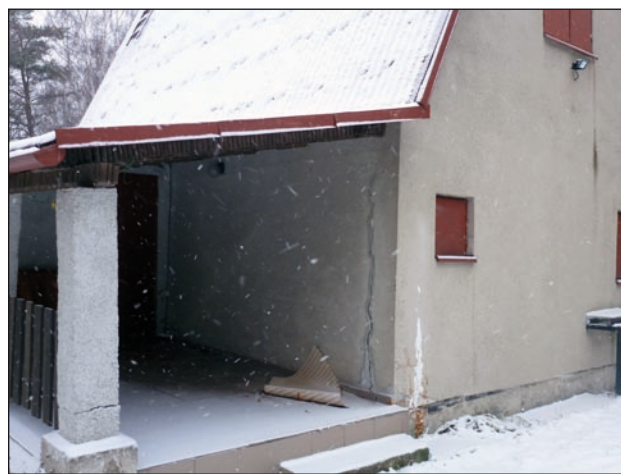
(Fig. 4). One cottage had to be even demolished (Fig. 5). The seriousness of the situation asked for a site stability analysis (Spišák et al., 2011). Due to the high material damage, but also out of concern about the threat to the security of the inhabitants (6 buildings are permanently inhabited), on 16. 12. 2011 the mayor declared in the village the emergency situation. The Section of Geology and Natural Resources MoE SR entrusted the State Geological Institute of D. Štúr (15. 12. 2011) to carry out a comprehensive engineering geological assessment of the site. The assessment consisted of reconnaissance of the landslide territory, the archive study (Petro et al., 1984; Šimeková et al., 2006) and the mentioned site stability analysis.

Fig. 4. Static breach of the cottage in the forest-park near Ruská Nová Ves. Photo L. Petro, December 2011.

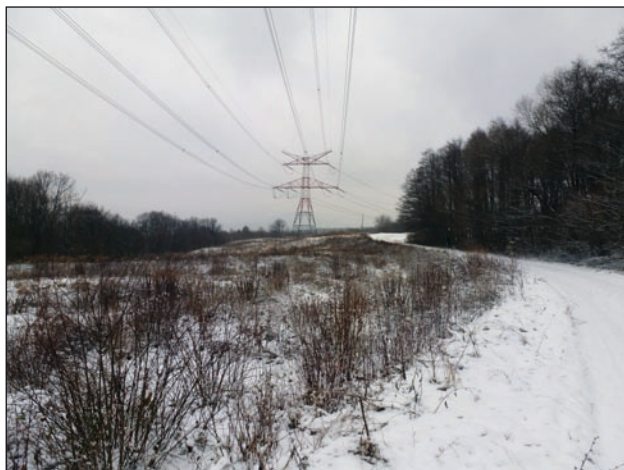
Fig. 3. Jeopardized VHV mast (400 kV) erected in 2011, located in the transportation part of the active landslide. Photo L. Petro, December 2011.

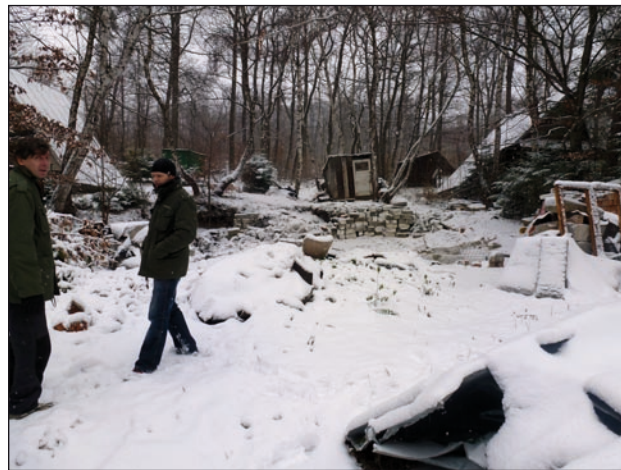
Fig. 5. The remnants of the cottage demolished due to serious damage by landslide in the forest-park near Ruská Nová Ves. Photo L. Petro, December 2011.

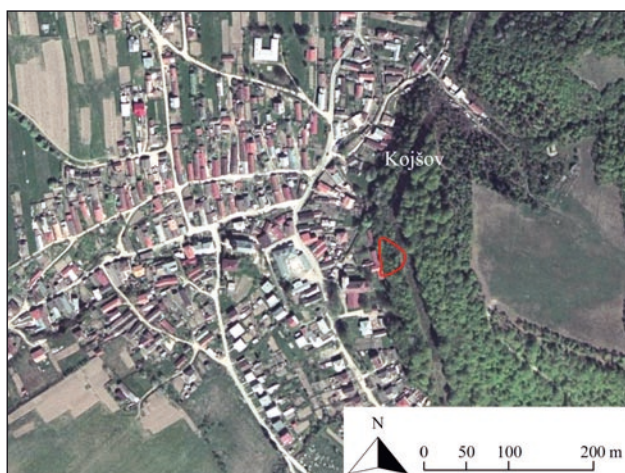
Fig. 6. Situation of landslide evolved in 2010 and re-activated in 2011 at the eastern outskirts of the Kojšov Village (No. 5 in Fig. 1).

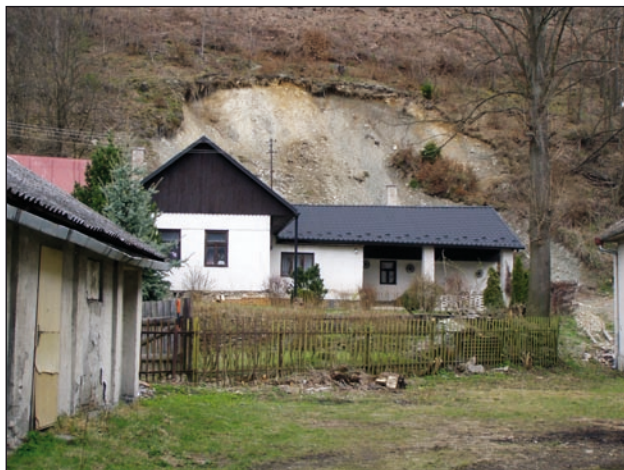
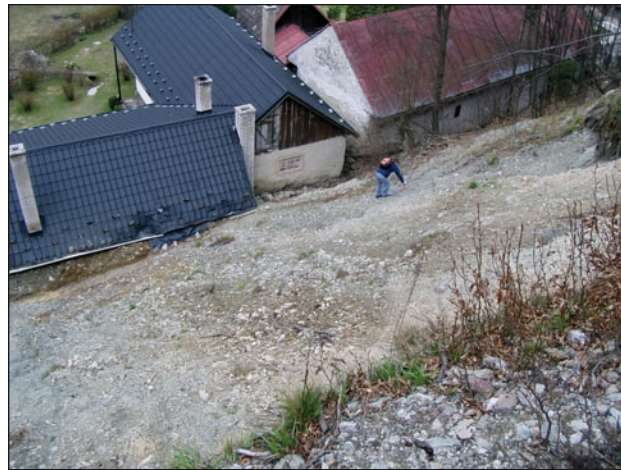
on the west slope. The landslide lobe heavily damaged the rear wall on the slope edge and the roof of the family house No. 275 (Fig. 7a, b). Serious static breach of the house required the construction of a wooden supporting structure in order to prevent further damage (Fig. 8). The owner of the house removed the accumulated soil from and partly beneath the roof and uncovered the uppermost part of the rear wall. In addition, he dug out a shallow ditch in order to conduct away the water seeping out from the slope. Despite these efforts these immediate remedial measures cannot be regarded as sufficient. Due to the geological structure and the nature of the terrain not only the house No. 275 is still threatened, but also the house located to the north of it (No. 274).

The sliding slope behind the family house No. 275 is built of grey and grey-green chlorite-sericite phyllites, eventually with intercalations of graphite-sericite phyllites, and fine-granular basaltic metamorphosed pyroclastics, which are affiliated to the Prakovce Member of the Smolník Formation of the Gelnica Group (Grecula et al., 2009). The rocks are schistose, weathered and at the surface strongly deteriorated into sharp-edged fragments. The fragments reach even the size of boulders (>200 mm), which use to fall off the slope. The phyllites are overlain by clayey-stony deluvial sediments of a thickness of 0.5 – 1.5 m. Two wet spots occur in the slope, indicating groundwater seeping out of the massif. The water flowing downslope gets below the foundations of the family house despite the interim surface ditch (Fig. 7b).

Fig. 7a, b. Views of the active landslide and damaged family house No. 275 in Kojšov. Photo L. Petro, April 2011.

In view of the persistent real threat to family house No. 275 and the safety and health of its inhabitants, it is necessary to implement as soon as possible the rehabilitation of the landslide slope. We would propose the following measures:

1. The adjustment of the slope and the removal of dangerous overhangs in the upper part of the main scarp along with removal of projecting and released boulders.
2. Excavation of a deep ditch (at least at the level of

30 cm below the surface of the base), 80–100 cm wide in the bottom part and approx 60 cm in the upper part, at least 60 cm from the family house. The excavated ditch should be left open as short as possible. In the case of rain, it is necessary to prevent the inflow of water into it.

3. Building up (in the excavated ditch) a revetment wall made of crushed stone, which should protrude at least 1 m above the bottom of the roof. The slope of the revetment wall should be around 80° tending into the slope. Behind the wall at the level of its base there should be placed a drain tube (diameter at least 100 mm) within gravel packing. In the body of the revetment wall the lateral drainage pipes of a diameter about 50–60 mm should be installed at a distance of about 1.5–2 m.

4. The incorporation of about 1 m high fence of thick metal mesh into the top of the revetment wall, which would collect the falling stones and fragments.

5. Excavation of about 50 cm deep drainage ditch for conduction of surface water off the landslide body and family houses, about 15 above the head scarp of the slip. In order to avoid the water infiltration into the slope, it should be paved with prefabricated or polyethylene elements.

6. Afforestation or grassing of the slope.

7. Ban of wood-cutting on the slope in the wider vicinity of the landslide.

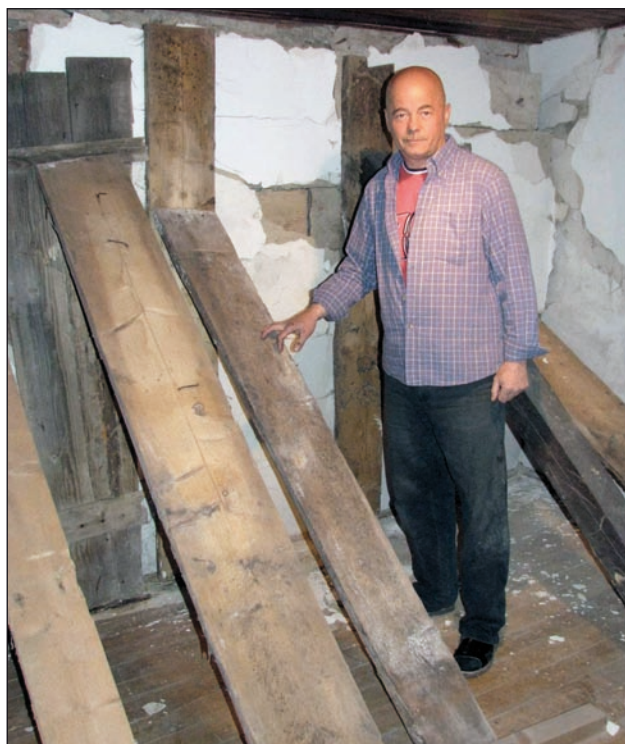
Fig. 8. Landslide-generated static breach of the rear wall of the family house No. 275 in Kojšov. Photo by homeowner, April 2011.

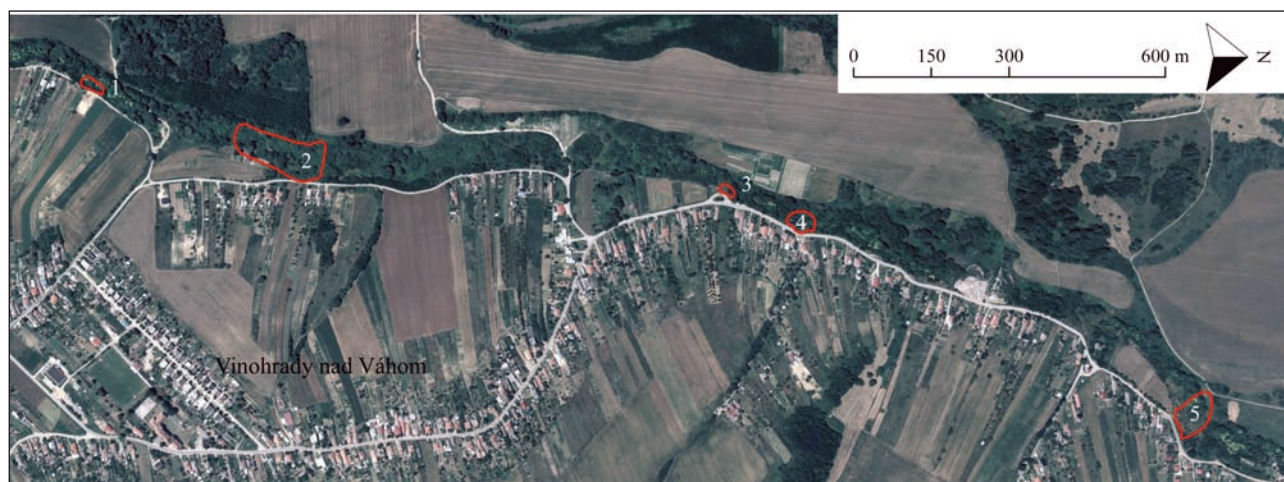
Fig. 9. Re-activated landslides of the year 2011 in the local parts of the village Vinohrady nad Váhom. (No. 19 in Fig. 1). 1 – Paradič; 2 – Kamenica; 3 – Pomorová; 4 – pri Kate; 5 – Pográn.

The landslides in the local parts Paradič, Kamenica, Pomorová, pri Kate and Pográn (Fig. 9) are located on the relatively steep and densely bushed western slopes. The landslide, which developed in the local part of Kamenica (Fig. 10), represents a serious threat to the double-house No. 711/712, whereas the head scarp is located in its immediate vicinity, directly below its north-western wing. In the other areas of the village the local communication was threatened.

The landslides in local parts Paradič and Pográn are of flow shape with well developed head scarp 4–5 m high. In the local parts of Pomorová and pri Kate there developed equidimensional landslides with the height of the head scarp around 3 m and relatively short transportation areas. The landslide in the Kamenica area has a character of an extensive slide with locally well developed head scarp and wide-opened lateral fractures. At the time of registration, the southern part of the head scarp reached to the north-west edge of the family double-house No. 711/712. The retrograde development of this disturbance would cause a static breach of the double-house and it has represented a serious threat to other houses, along the street above in slope and also to local communication. A negative omnipresent phenomenon observed in the sliding territories Paradič, Pomorová and Kamenica were surges of groundwater, in particular the head scarp zones. This water flew into uneven morphology of the landslides and fills up the depression and saturated the sliding masses.

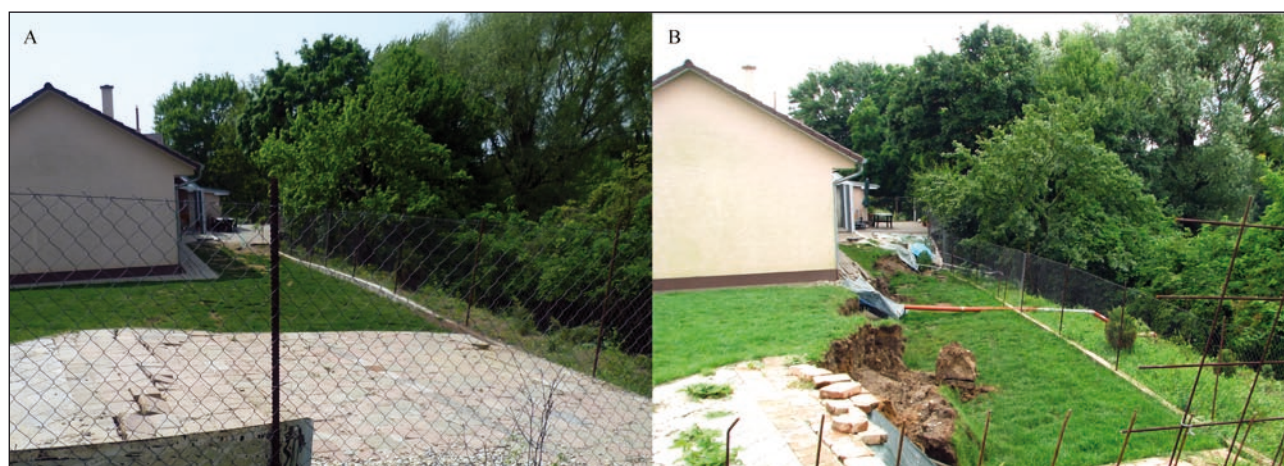
Fig. 10. Family double-house endangered by the landslide in Vinohrady nad Váhom – part Kamenica. A – recorded on 28. April 2011 (Photo M. Bednarik); B – recorded after Declaration of Emergency Situation, 22. June 2011 (Photo P. Ondrejka).

mainly the local communication and the gas piping. In the local part Kamenica, the landslide threatened the family double-house. The communal representation was forced to ask for help the Ministry of the Environment, which in turn (by means of the Section of Geology and Natural Resources) asked the State Geological Institute of Dionýz Štúr to carry out survey, the documentation and geodetic levelling of the five sliding partial territories. A survey was carried out on 28. April 2011.

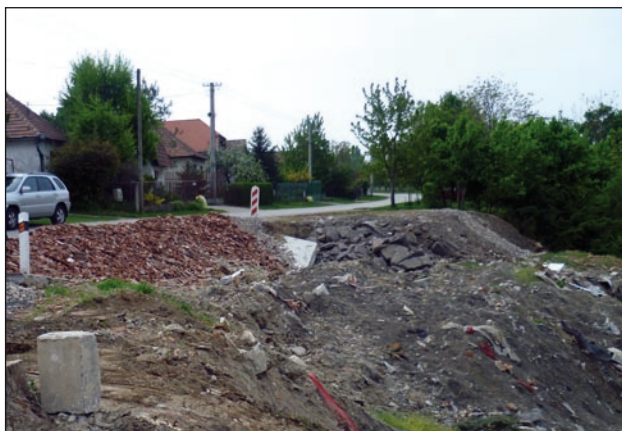
During the April registration we have concluded, the inappropriately targeted anthropogenic activities were one of the main factors that contribute to the destabilization of the territory. This was in particular the creation of illegal landfills in the areas of head scarps of the potential slope failures. The residents of the village had adopted the ill practice of waste deposition in the vicinity of local communication in order to prevent its destruction. Moreover, in the territory of interest also intensive construction of family houses has taken place. The constructions themselves represent a surcharge to the slope, attenuated by backfilling of the depressions and other earthworks.

Fig. 11. Head scarp of the landslide Pográn with illegal landfill. Photo M. Bednarik, April 2011.

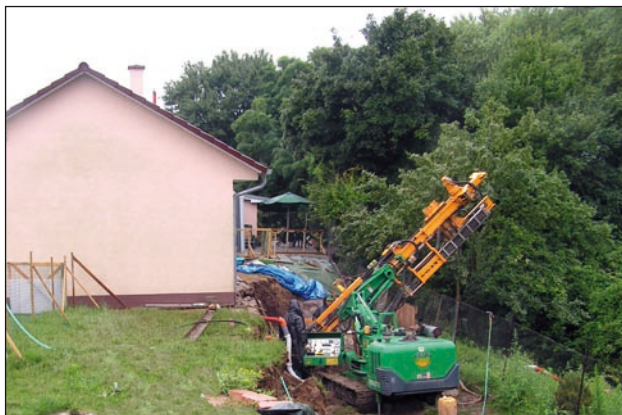
Fig. 12. Remedial works aiming on the rescue of the family double-house No. 711 a 712 (construction of the anchored micro-pile wall). Photo I. Dananaj, June 2011.

The biggest problem was the rescue of the family double-house, which is found directly on the head scarp of the landslide. After the implementation of the engineering geological survey there was designed and implemented anchored micro-pile wall (Fig. 12). The groundwater table level was drawn down by subhorizontal drainage borehole V-8 directly below the double-house at a depth of about 7 m.
