# Methodology and results of geological survey of the environmental burden of the former Slovenský hodváb plants – Senica (Slovakia)

**Abstract:** In the years 2021–2023, the State Geological Institute of Dionýz Štúr, Slovakia, carried out a detailed geological survey of the environmental burden on the Senica site, identified as a probable environmental burden with a high priority within the project Geological survey of selected environmental burdens ŠGÚDŠ-3. The task was carried out in accordance with the strategic planning document for a systematic survey and removal of environmental burdens entitled *State Program for Remediation of Environmental Burdens of the Slovak Republic (2016–2021)* within the Operational Program of Environmental Quality. The goal of the survey was a detailed verification of all components of the environment at locations that, based on a preliminary risk assessment in the information system of environmental burdens, represented a potential risk for human health and the environment. The survey verified in detail an area of approximately 37 ha, on which 210 chemical indicators were analytically determined from a wide range of indicators according to the ty

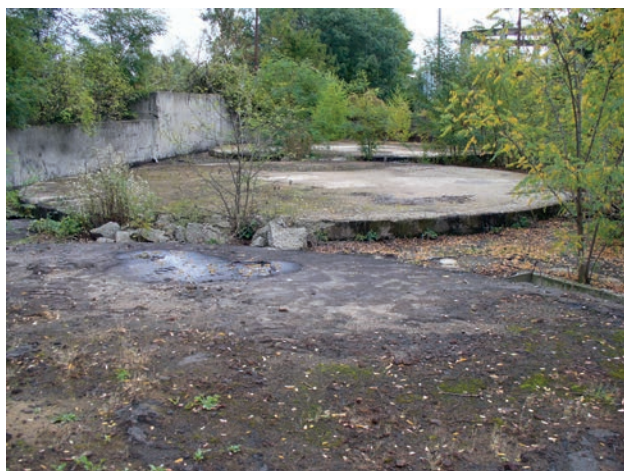
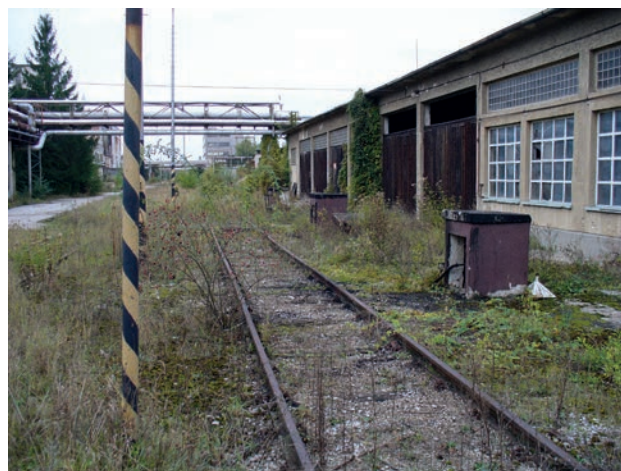
**Fig. 2.** A view of the site where tanks of the former fuel oil industry and chemicals were located (IS EZ, 2014).

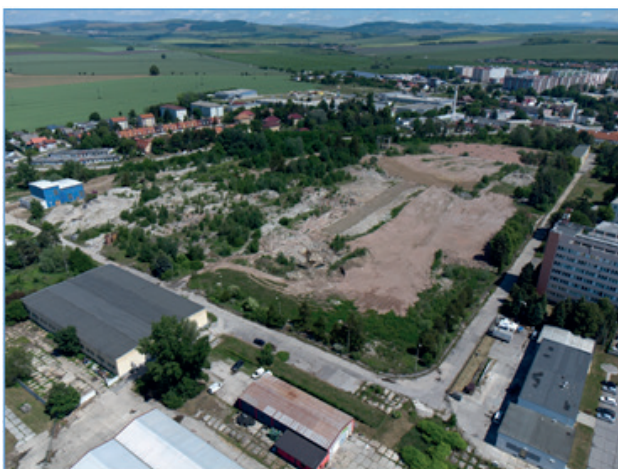
In the eastern part of the territory, in the places of the most probable source of pollution, extensive construction and remediation activities were taking place, with land modification intended for further development activities of civil and housing construction. Decontamination and subsequent improvement of the land was carried out based on the recommendations of the environmental audit in the area of Slovenský hodváb PLUS, s.r.o. (Žitňan, 2011), consisting in the partial demolition and reconstruction of old decaying buildings, the removal of the existing fuel oil plant and demolition of the factory chimney (Fig. 3).

**Fig. 3.** Views on the reclaimed eastern and western industrial part of the area after sanitation and reclamation as well as its surrounding (taken from Grexová et al., 2023).

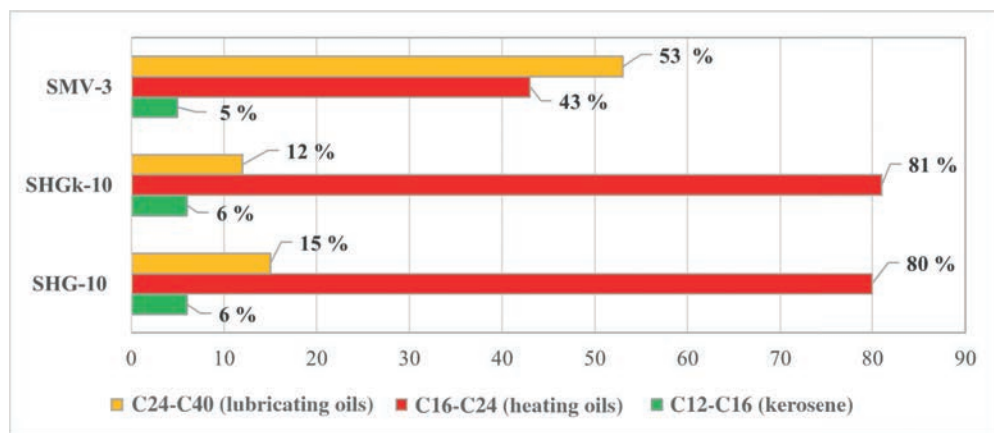
hydrocarbons in the rock environment in the investigated location, when the concentration of NEL-GC exceeded the IT criterion of the Ministry of the Interior of the Slovak Republic No. 1/2015-7 pointed out in the case of the hydrogeological monitoring borehole SHG-10 (1.5–2.0 m above sea level) and SHGK-10 (control sampling) and in the mapping borehole SMV-3 (0.2–0.5 m above sea level) for the dominant percentage representation of hydrocarbons of the C16–C24 series (heating oils; Fig. 8).

**Fig. 8.** Concentration of individual hydrocarbon fractions in the rock environment of the biological contact zone in the soil samples taken from the hydrogeological monitoring well and the unequipped mapping well with high C10–C40 (taken from Grešov et al., 2023).

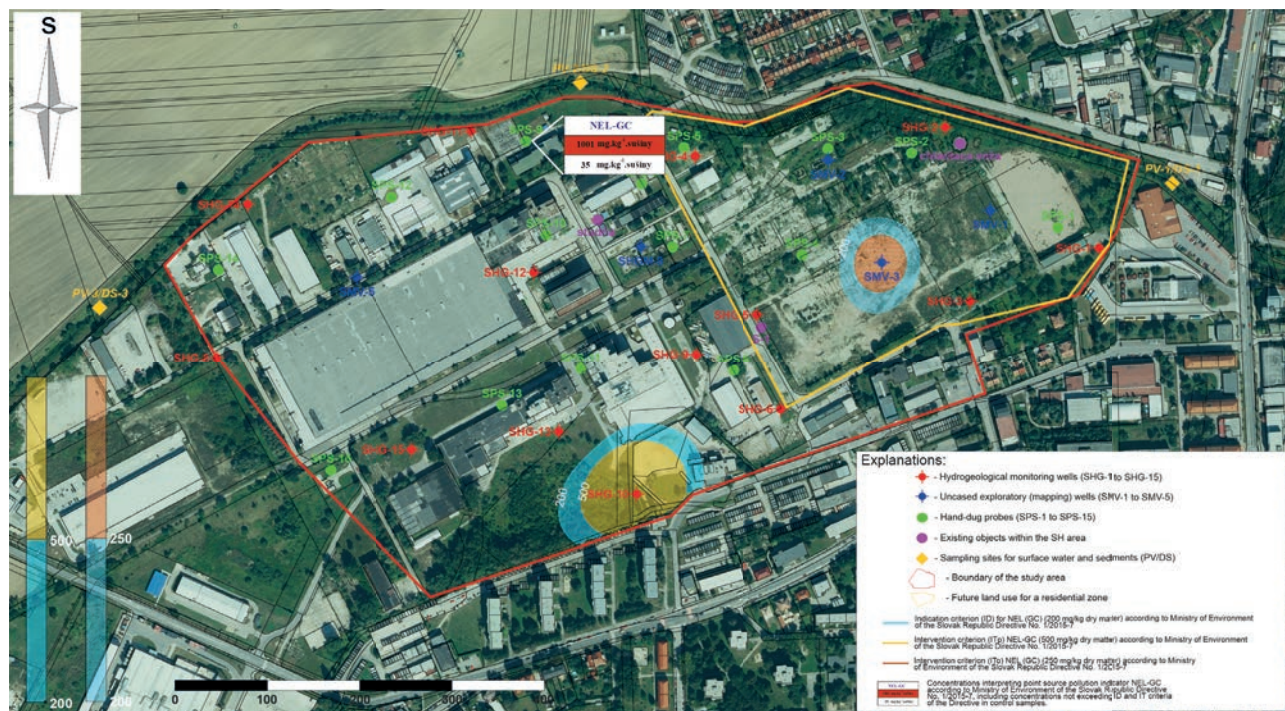
Local pollution by aliphatic petroleum hydrocarbons of the rock environment of the biological contact zone is illustrated in Fig. 9. The pollution is characterized by residual hydrocarbons that have the character of low-

volatile hydrocarbons, with low solubility and a high degree of retardation (limitation of migration) in the rock matrix. The confirmation of the local presence of this hydrocarbon in part of the investigated area is, according to the oral information of the current owner, a consequence of the remediation of the hot water boiler for burning fuel oil in 2000, which in the past ensured the central heating of the city of Senica, and therefore with a high probability it is a residual pollution. In summary, it can be concluded that the slightly increased concentrations confirmed only in manual probes are with a high probability point pollution of a residual nature as a result of the implemented partial rehabilitation of objects in the planned residential

**Fig. 9.** Areal distribution of petroleum hydrocarbons in the studied site (taken from Grešov et al., 2023).

zone, which, according to the recommendations of the environmental audit (Žitňan, 2011), resulted in the removal of a potential source of contamination.

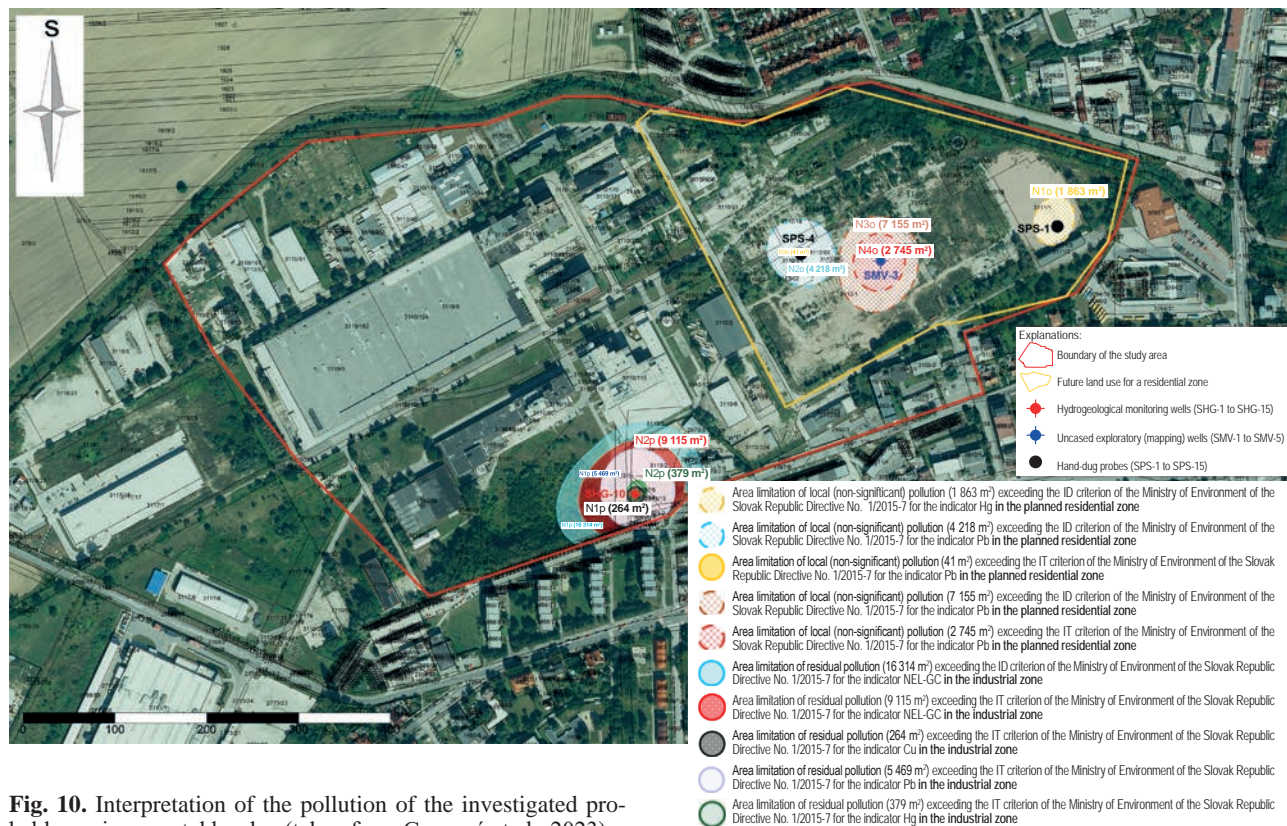
Fig. 10. Interpretation of the pollution of the investigated probable environmental burden (taken from Grexová et al., 2023).

the area of the former plants is shown in Fig. 10. Fig. 11 shows the situational model of the site, which is based on the results obtained from the geological survey according to Annex 4 to the directive of the Ministry of the Interior of the Slovak Republic No. 1/2015-7, which characterizes sources and centers of pollution, migration possibilities

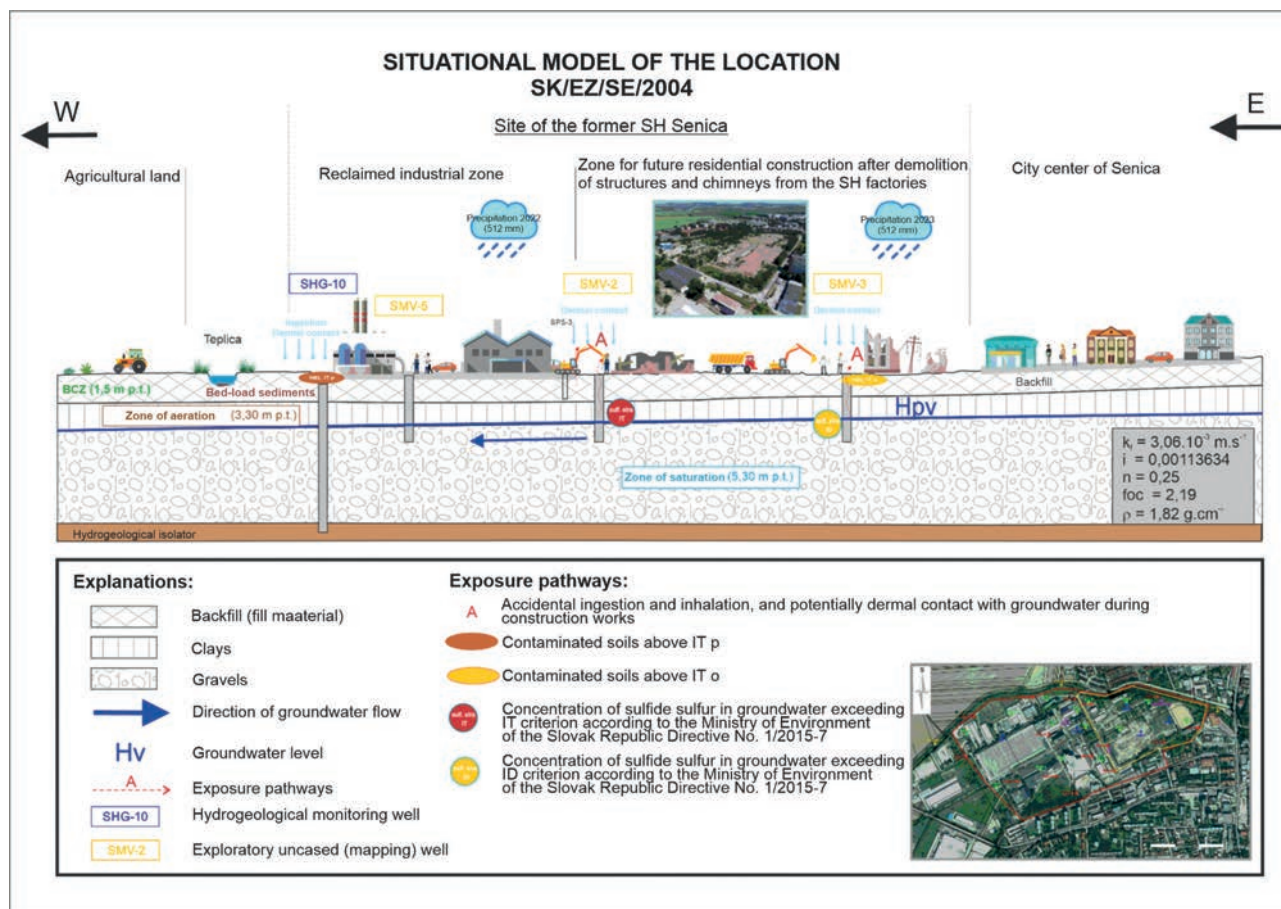
Fig. 11. Situation model of the site (taken from Grešov et al., 2023).

and possible transport routes of pollutants in the subject area. It also shows sources of environmental pollution as well as exposure scenarios in connection with the receptors present. The elaborated risk analysis did not identify an environmental or health risk, there was no need to propose costly remediation of the site.
