8. Geotechnical Monitoring of Landslides on Slopes of Water Reservoirs

MILOSLAV KOPECKÝ, MARTIN ONDRÁŠIK and DARINA ANTOLOVÁ

The article evaluates stability (monitoring results) of landslides next to two major water reservoirs in Slovakia. The first is a landslide at the water reservoir Liptovská Mara, which with its volume of water 362mil. m³ is the largest reservoir in Slovakia put into operation in 1975. The purpose of this hydraulic structure is to use the hydro power potential of the Váh, to improve the flow of water under the dam and to protect the area from floods. On the right side of the dam body there is landslide displacing about 5mil. m³, which strikes the reservoir with its toe. The second landslide is a landslide on the water reservoir Nová Bystrica, located over the reservoir water level, but its possible instability is threatening the water discharge object. Both landslides are located in the geological environment of Carpathian Flysch. The article assesses a current stability of landslides, remediation measures and especially results of a long-term monitoring.

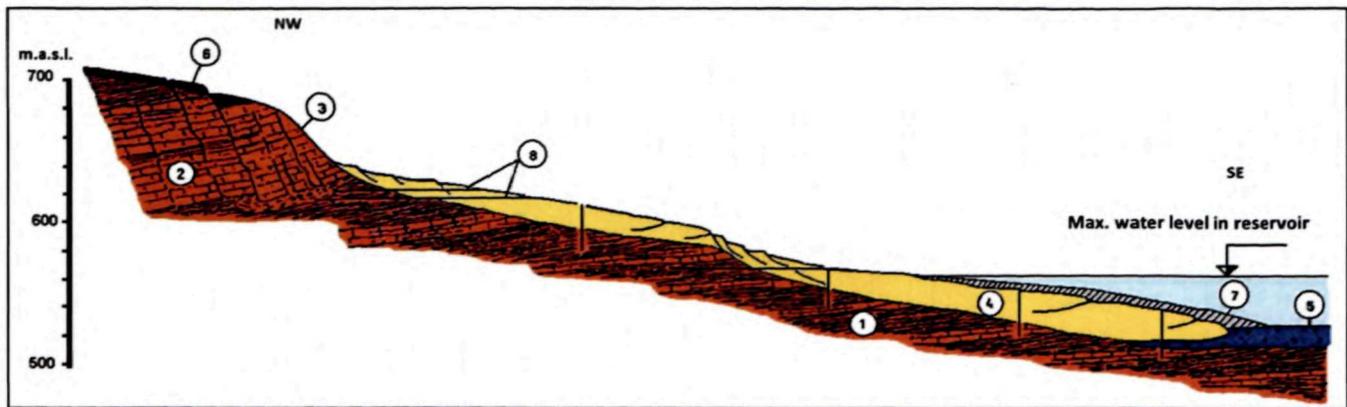
Fig. 8.3 Profile through the landslide Liptovská Mara (modified after Nemčok, 1982)

The stability calculation of the Veľkomarský landslide performed prior to the WR construction had appointed to low stability of the slope. The calculation result meant concern about significant instability of the landslide after finishing the dam construction due to water buoyancy acting on the accumulation zone of the landslide.

To improve the Veľkomarský landslide stability condition after finishing the construction of the WR the following remediation measures were taken (Fig. 8.4):

- building of stabilization anti-abrasion embankments consisting of gravel and sand on the landslide toe (in 1974-1975) – the thickness of the embankments is 7 m (volume 700,000 m³),
- realization of horizontal drainage boreholes (HDB) - 4 stages in 1974-1977,
- creating a system of surface drainage gutters (in 1976-1978).

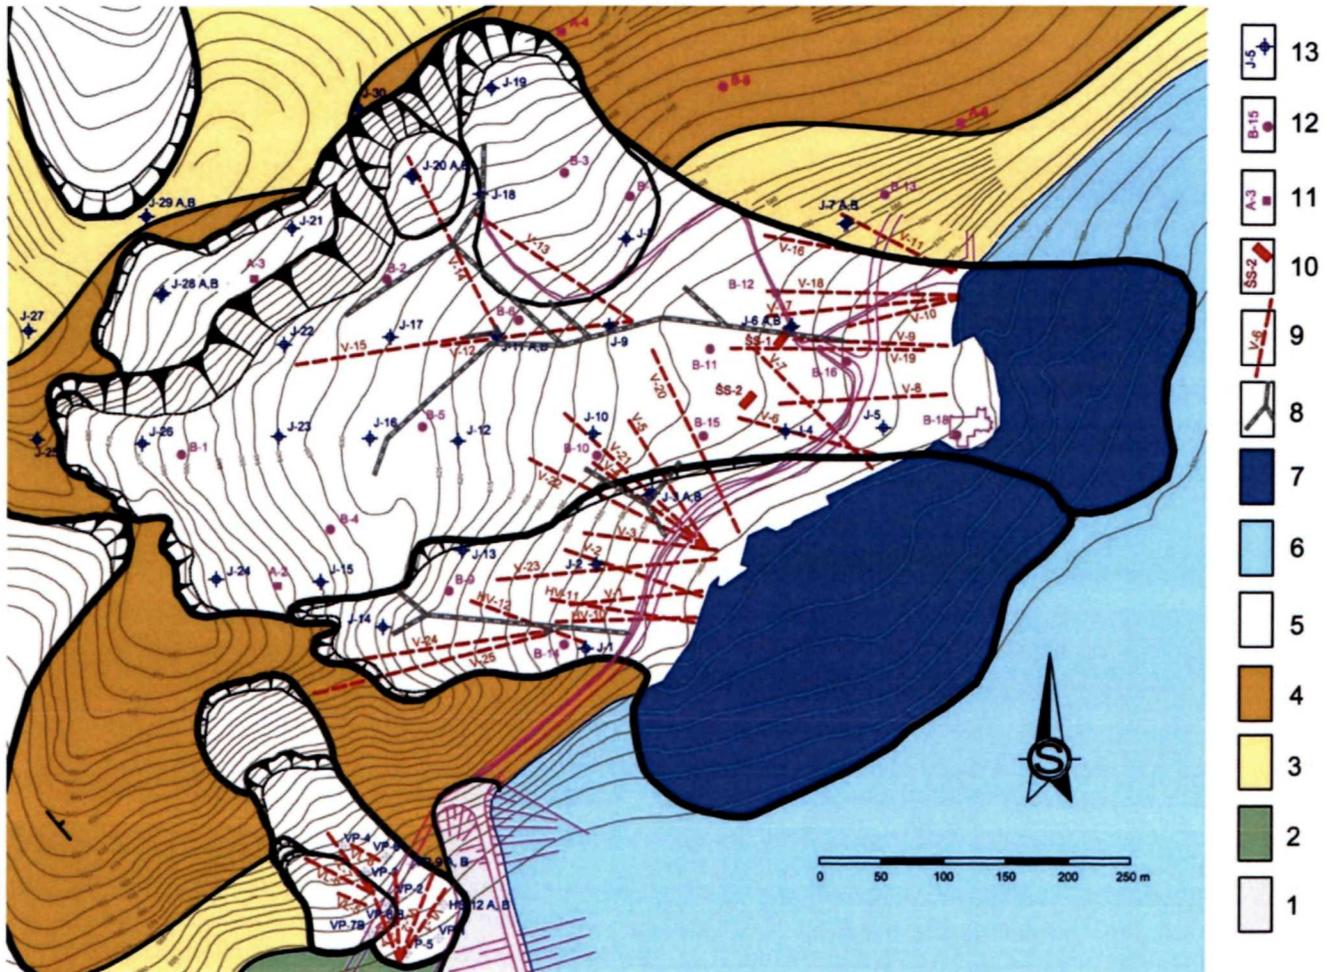
The monitoring network (Fig. 8.4) of both landslides was built 40 years ago. On the Veľkomarský landslide in 1974-1975 there were built sites for observation of groundwater table levels (observation wells - 30 pcs). As remedial measures also 28 horizontal drainage boreholes (HDBs) with the total length of 3,800 m were built in 4 stages.

Fig. 8.4 Scheme of existing monitoring points and remediation measures on the Veľkomarský and Malý Vlašiansky landslides (Kopecký, 2010)

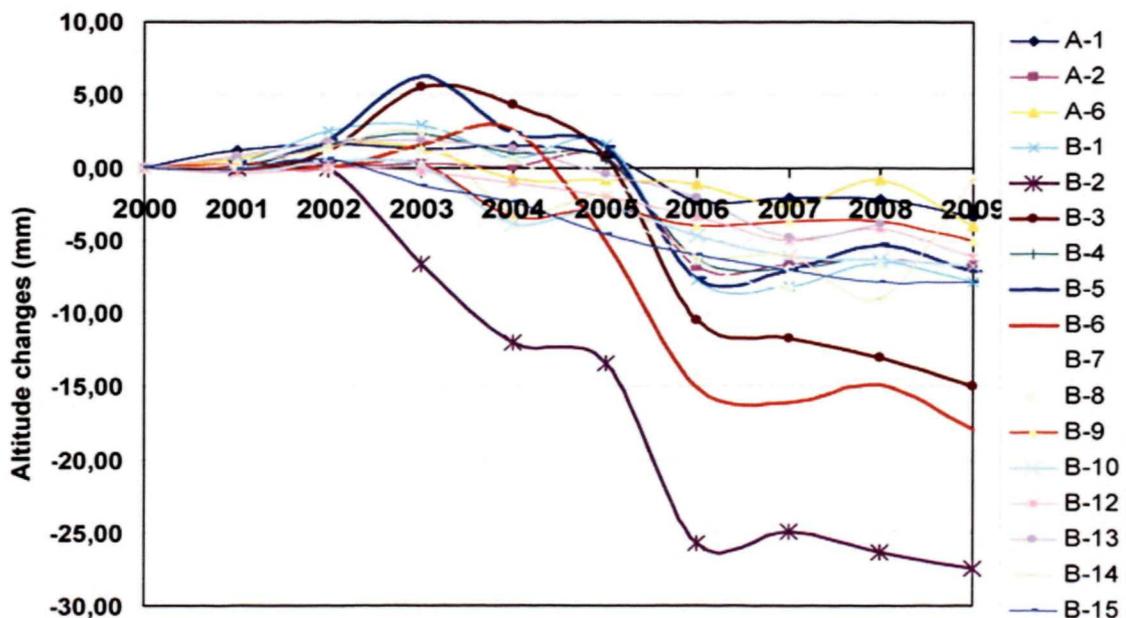
In late March 2006, a sudden warming and rapid melting of very thick snow cover led to infiltration of water from the melted snow into massif what resulted in increase of groundwater table levels in the sliding slope to the maximum one ever observed during the entire

monitoring history. These high groundwater table levels were synchronous with changes of elevations of the observation points. A significant decrease was recorded on points from B-1 to B-6, which are located in the head of the landslide area (from 6.9 to 12.2 mm – 9.8 mm on average!, Fig. 8.5), what indirectly pointed to a partial activation of the landslide area.

Fig. 8.5 Cumulative curves of altitude changes (mm) of geodetic observation points during years 2000-2009

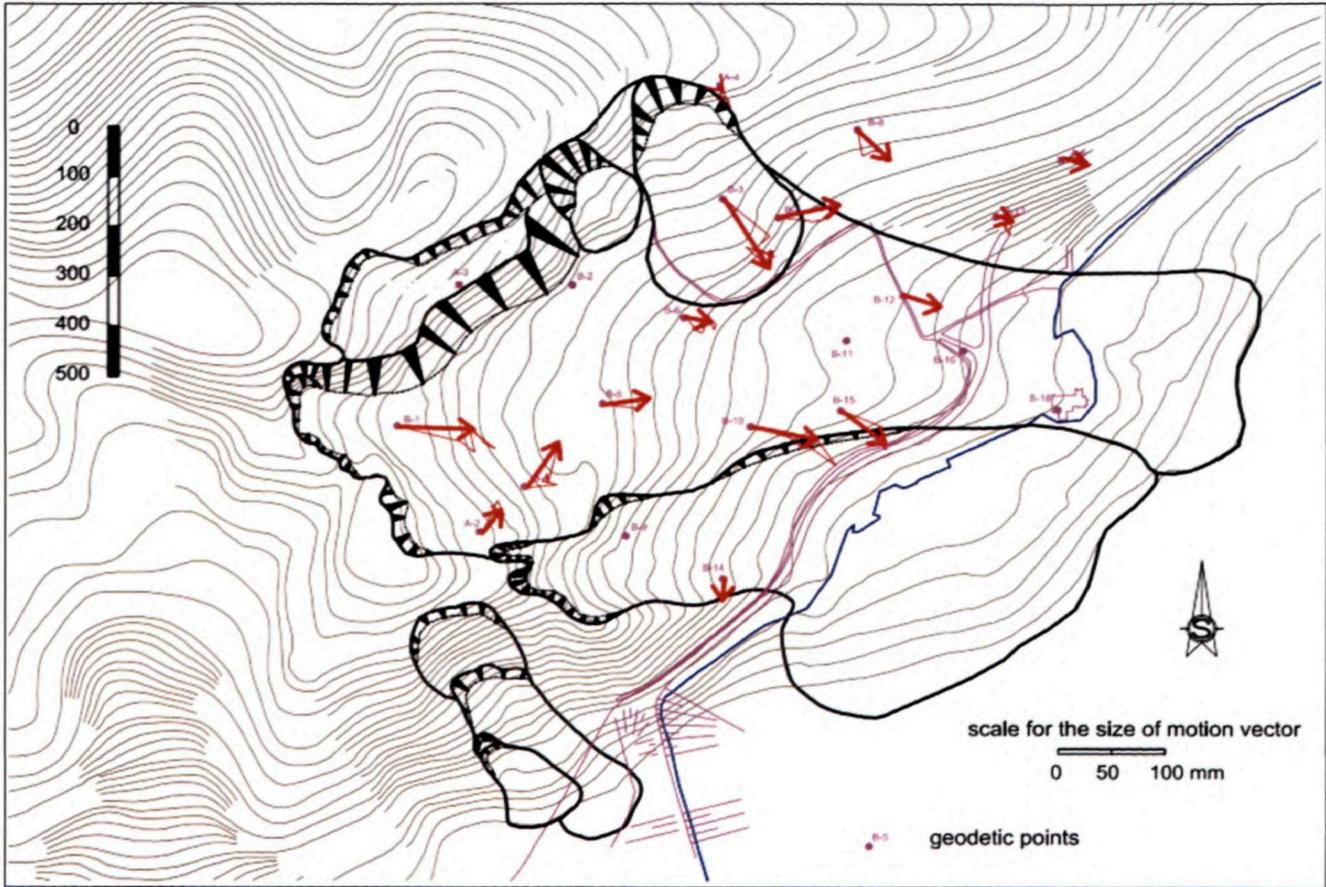
Since 2007 geodetic measurements of displacement of geodetic points are made by method GNSS (Prvý, 2010), because there is no problem, with influence of the undesirable movement of the control points. The resulting vectors of the displacements of the geodetic points are given in Fig. 8.6. These vectors already could suggest the real trend of movement of the landslide surface. The maximum observed values of movement were 80 mm, this means ca 10 mm per year on average.

Fig. 8.6 Horizontal displacement of fixed and control points during period 2007-2013 by method GNSS

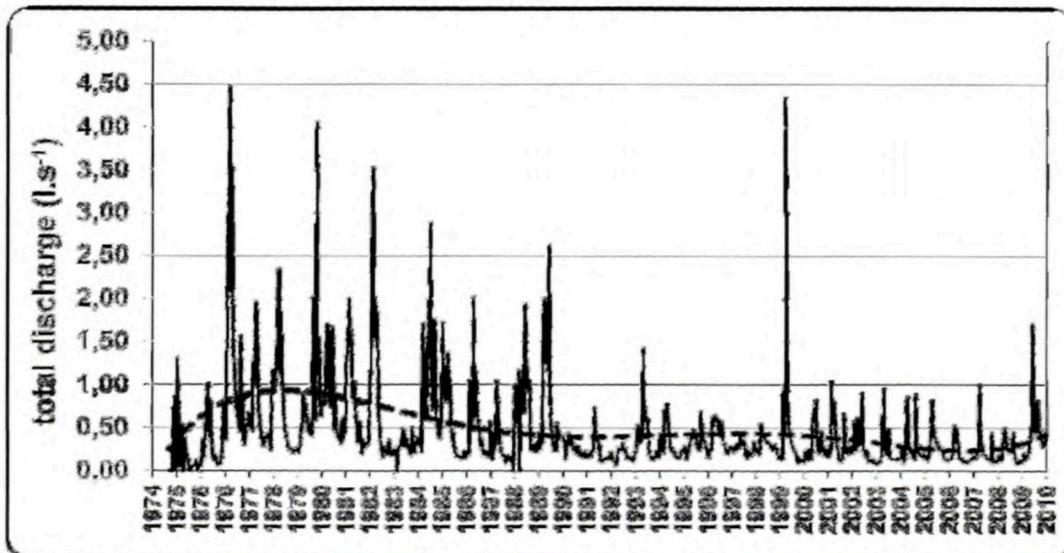
With regard to the long term monitoring of the HDBs discharge, it is possible to observe decrease of the total volume of the water being removed from the landslide (Fig. 8.7).

However, this overall groundwater level (GWL) decline does not have to play a role in reduction of the local slope stability, unless due to decrease of the water discharge from HDBs the groundwater level is not increased in the nearby observation wells. The negative impact of the discharge decline in HDBs from V-12 to V-15 located in the landslide head area is quite obvious. In this area (Fig. 8.4), in observation wells J-16, J-17 (Fig. 8.8), J-18, J-11B, J-11A the groundwater level is

Fig. 8.7 Downward trend of the total discharge from all HDBs on the Velkomarský landslide

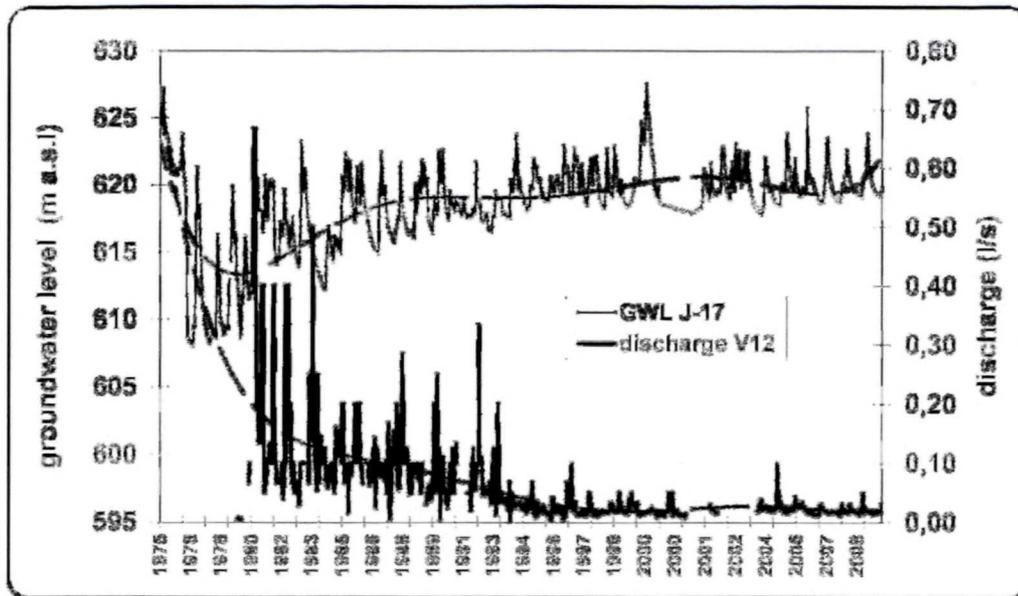
increasing for long time period, in the case of J-11A the groundwater freely flows out of the well as from artesian well. Inspection of the horizontal drainage boreholes was made with use of camera (Fig. 8.9). The largest throughput was observed only up to 30 m. In most cases the camera got only a few meters away from the HDBs mouth. The inspection results have pointed out that the broken HDBs should be either cleaned or replaced by new HDBs.

Fig. 8.8 Decrease of functionality of HDB V-12 and GWL rise in observation well J-17

The proposed measures were split in to 3 stages – Tab. 8.1. Emphasis is placed especially on the building of inclinometer boreholes and reconstruction of network of geodetic points, because stability (or better dynamics) of any slope can be judged the best way by combination of geodetic measurements of the surface movement with inclinometric measurements of movement below the surface. It will be also necessary to clean the existing HDBs.

If such measures prove ineffectiveness, it will be necessary to proceed with a construction of new HDBs.

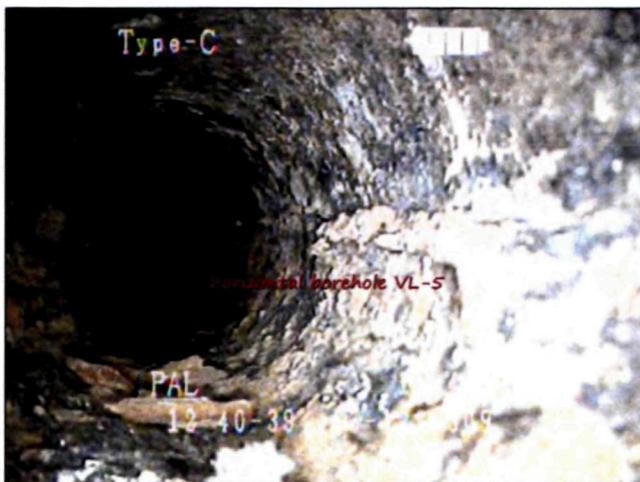
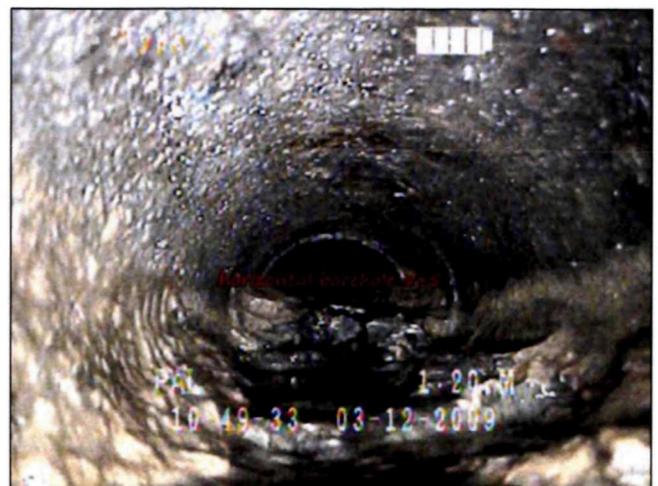
Fig. 8.9 State of the HDB casing after 38 years in operation revealed by the camera inspection

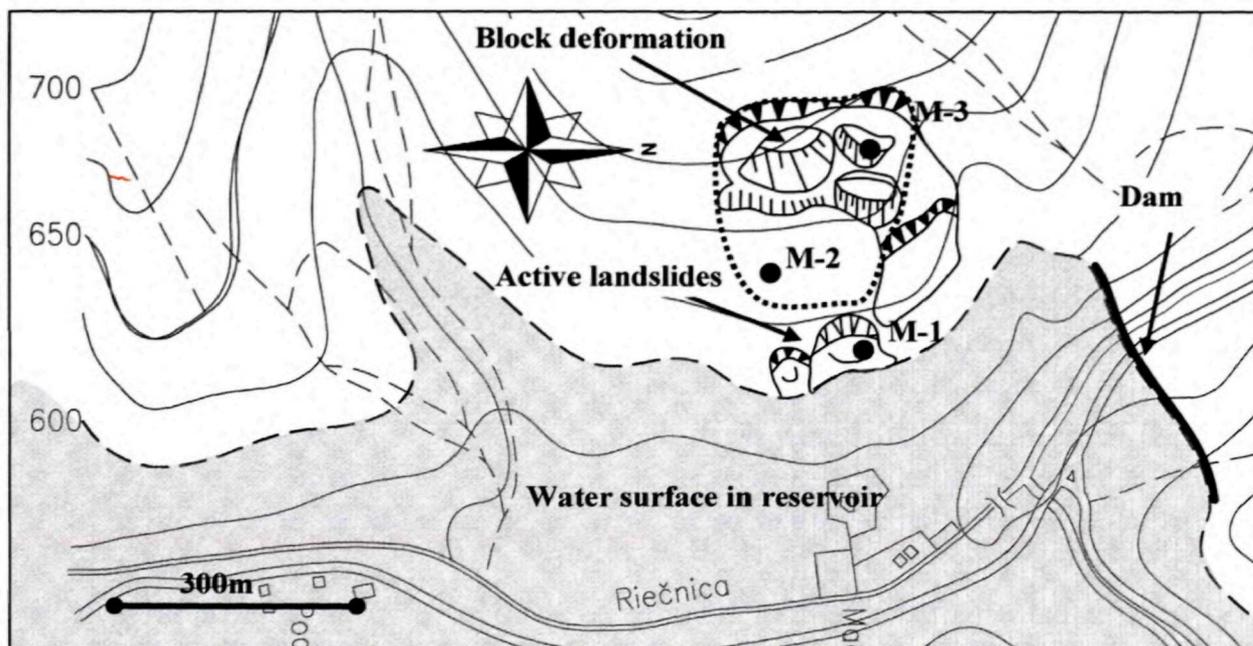
Fig. 8.10 Scheme of the landslides at the slope located on the dam left-hand side

slope. In the area between the reservoir shoreline and the forest road there are active landslides with overall area of about 120x60 m. The landslides were probably caused by improper intervention during construction of the forest road. Active landslides are bound only to the slope debris containing coarse fragments from 40 to 80% and the slip surfaces were detected by the inclinometric measurements at depths from 3.5 to 5.0 m. In the higher part of the slope (in the range of about 630-690 m above sea level) there is a block deformation (Fig. 8.10). Based on initial investigation works (Jadroň & Fussgänger, 1993) its dimensions were estimated to approximately 100 x 140 m. According to our latest knowledge, this could be up to 220 x 140 m (dotted line in Fig. 8.10). Block deformation is result of gravitational movement of relatively rigid sandstones over the layer of plastic claystone. During the movement from the main scarp zone the sandstones were disintegrated to individual blocks. The

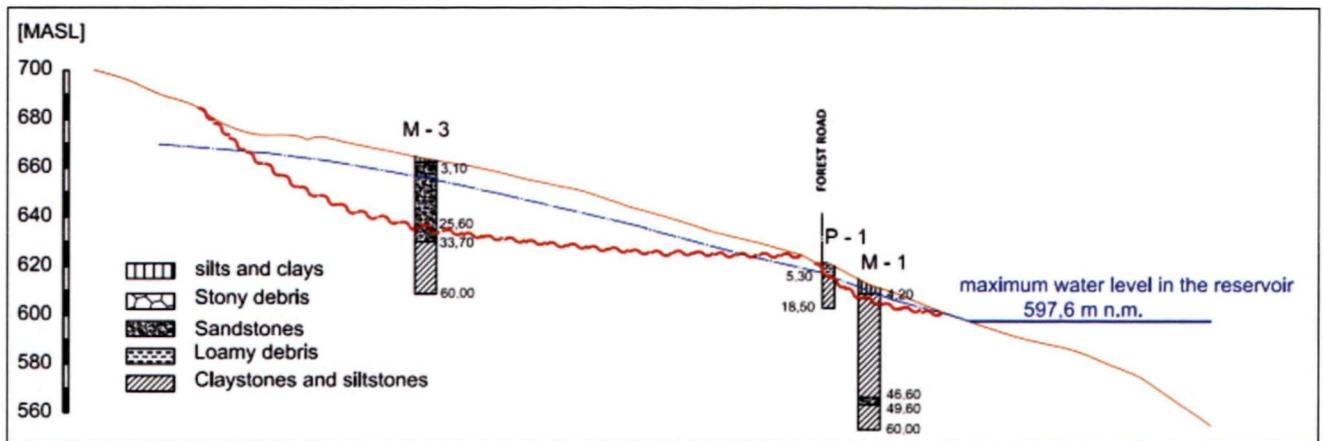
maximum depth of the slip surfaces was detected by inclinometric measurements at a depth of 34.0 m below the surface (Figs. 8.11 and 8.13).

Fig. 8.11 Profile across block deformation and active landslide on the slope above the water table level in the reservoir

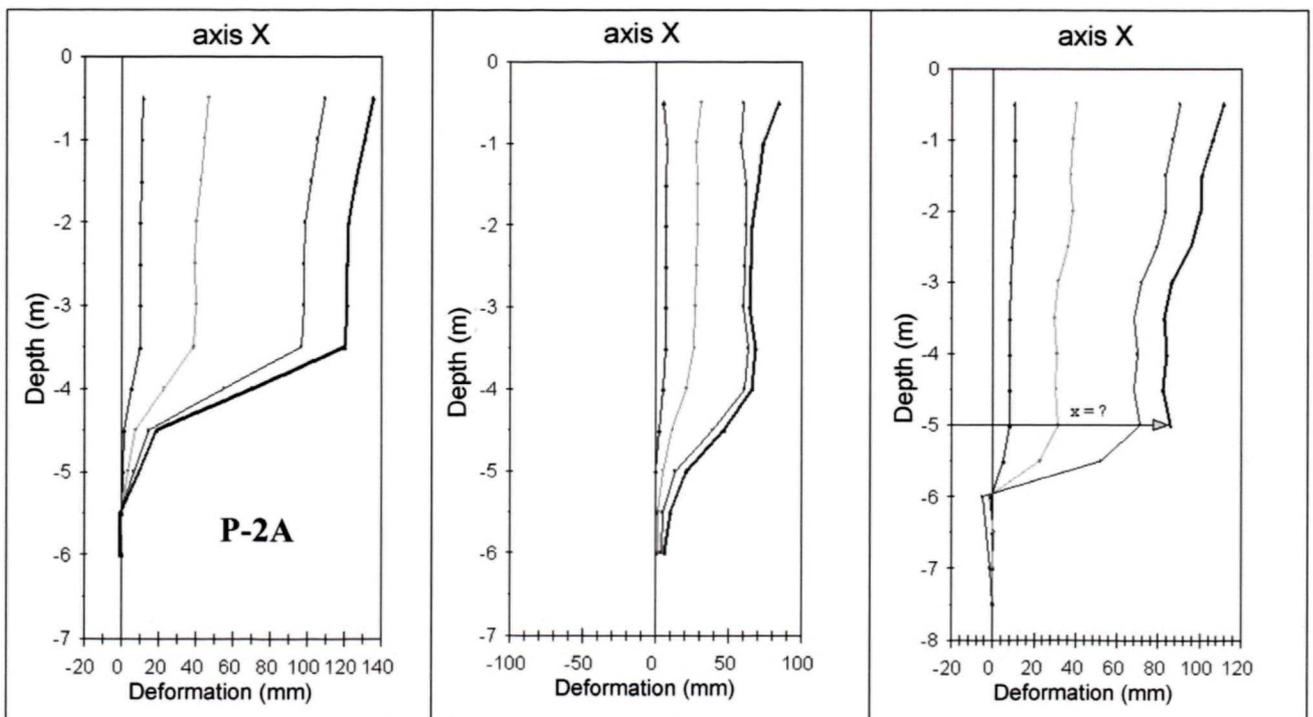
Fig. 8.12 Movements in three inclinometers, including P-2A, located in the active landslide on the forest road

In the landslide area with the forest road it has been confirmed that the activity of the movement still persists. The maximum deformation observed from 1993 to 2006 was 300 mm (sum of deformations from two inclinometers - the second one replacing the first one damaged). The movement is probably not continuous and uniform, it occurs only under extreme climatic conditions (excessive rainfall and snow melting). The depth of the slip surface of the active landslide on the forest road was found 3.0 - 5.5 m below the surface (Fig. 8.12).

It is obvious that, provided no remediation works will be made on the active landslide area with the forest road (Kopecký & Hruštinec, 2006), than in some time there will be an absolute destruction of the slope and sliding of the deluvial sediments to its lower part and partially into the water reservoir. About 55,000 m³ of debris can be mobilized. However, we assume that in this process there is no threat to the inflow waterworks facility remote about 150 m from the accumulation of the active landslides. On the other hand, removal of rock masses from this area can cause acceleration of movements of the block deformation situated above the forest road.

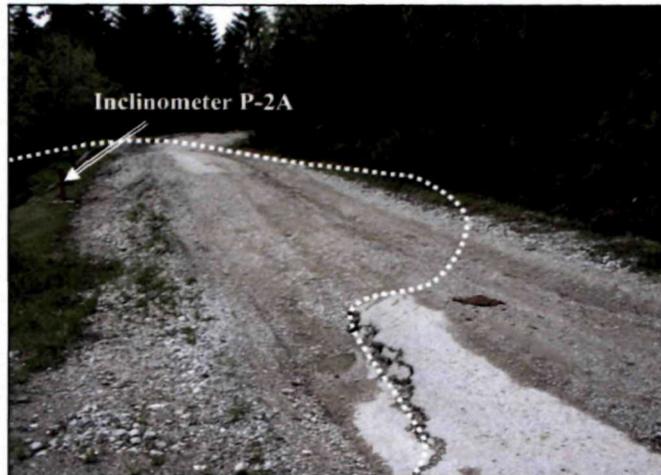
Based on the analysis of the inclinometric measurements it was found in 2 inclinometric boreholes located outside the presumed area of the landslide active in 1993 that since 1999 there was gradual expansion of the landslide and significant distortion of the forest road (Fig. 8.13).

Fig. 8.13 Main scarp area of the active landslide in the body of the forest road with inclinometer P-2A

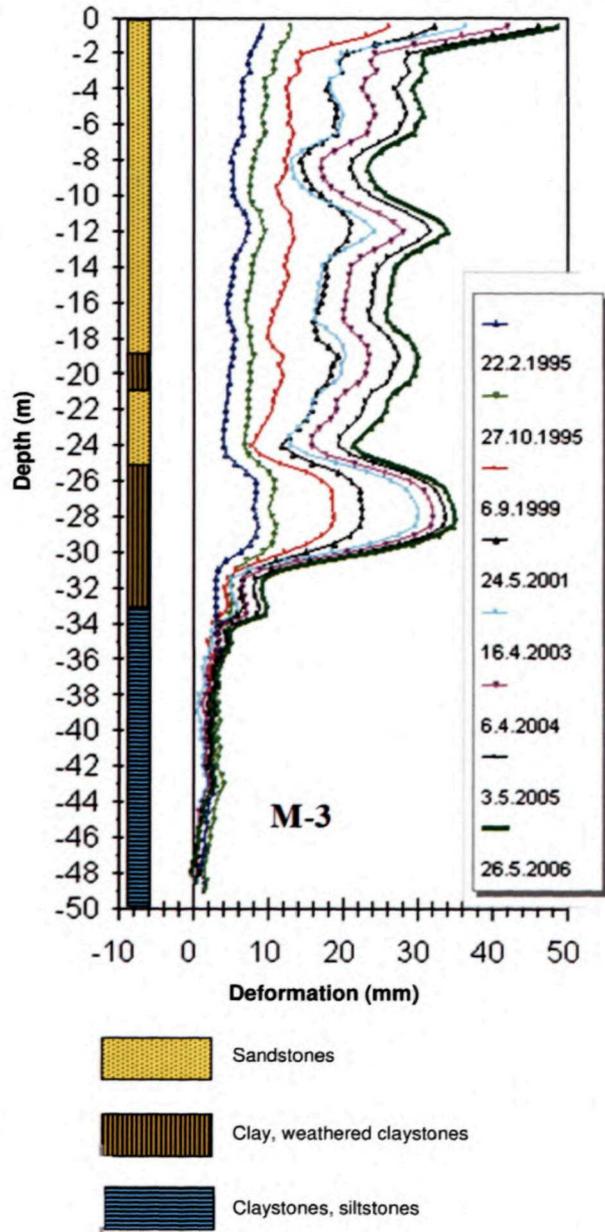
The block deformation, which is situated in the slope above the forest road, there is a gravitational movement of relatively rigid sandstones over the surface of a plastic claystone. Inclinometric measurements under the main scarp zone of the block deformation (borehole M-3 - Figs. 8.10, 8.11) confirmed the existence of a relatively thick slip zone (about 7 meters), along which there is a movement of the block of sandstone up to 34 meters thick (Fig. 8.14).

Fig. 8.14 Inclinometric measurements in the borehole M-3 located in the block deformation

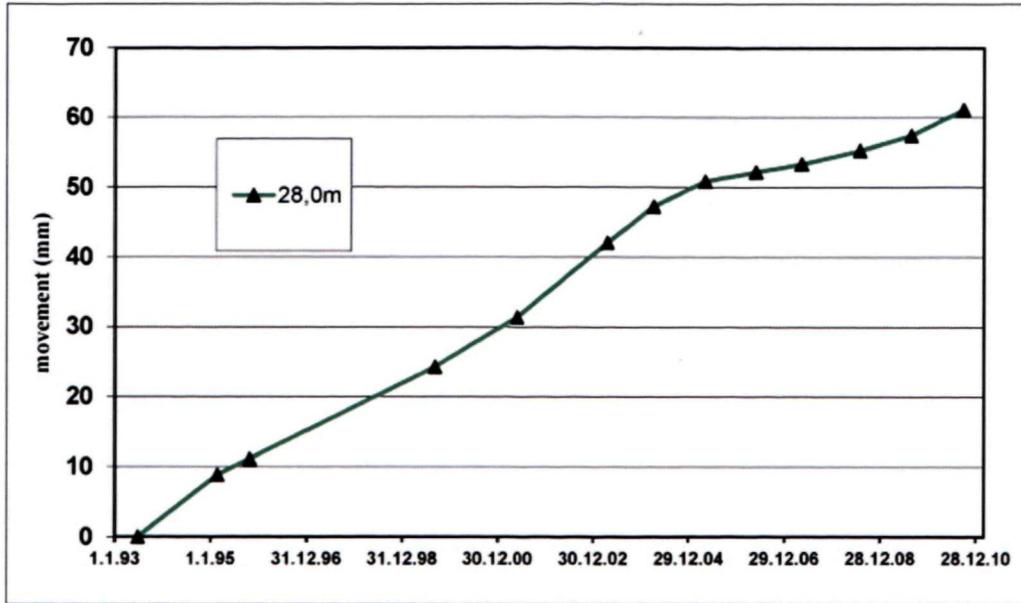
Total movement of 47 mm during 15 years was detected. However it is important that the movement at a depth of about 28.0 meters is relatively uniform up to now (Fig. 8.15).

Fig. 8.15 The curve of movements vs time in depth 28.0 m in the borehole M-3

ated motion or movement is steady is crucial to the prognosis of further development of the movements (Fig. 8.15). However, as the inclinometric measurements are carried out only once a year, it is not possible to determine the nature of the movement reliably.

If there are demonstrably accelerated movements in the area of the block deformation, it will be necessary to proceed to remedial or other measures, because at certain acceleration it will not be possible to stop the given movement. The subsequent movement of the rocks would likely jeopardize the operation of the water reservoir.
