## Using the possibilities of aerial photogrammetry for the research of quarry enlargement

### Abstract

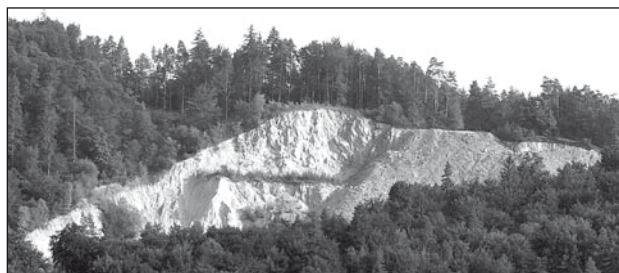
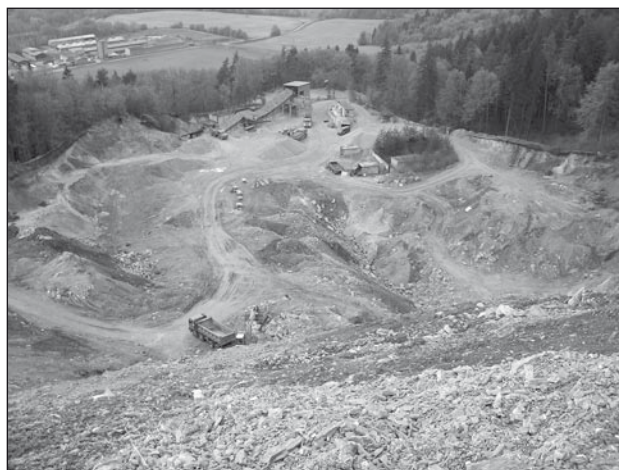
**Figs. 2 and 3.** Kiár quarry on the northern slopes of Bystrická vrchovina highlands, the waste dump is situated in the right part of the quarry (left). The view from the dump to central part of the Kiár quarry (right, photo P. Hronček).

the company KARTIK s.r.o. Banská Bystrica. The present quarry shape is considerably changed by a waste dump of soil and rock material which has been stockpiled in the southern part of the quarry since 2003 (Figs. 2 and 3).

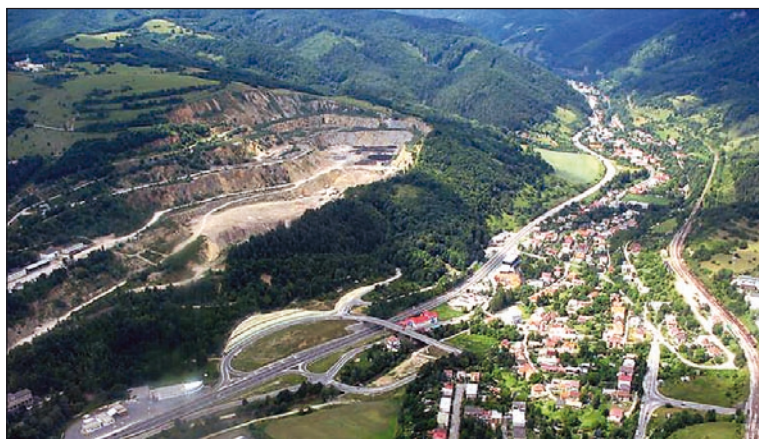
**Fig. 9.** Aerial view on the Kostiviarska quarry in 2009 (photo Z. Filadelfi).

The largest quarry of the Zvolenská kotlina Basin is located on its northern border at the western skirt of Kostiviarska, the local part of the town of Banská Bystrica (Fig. 9). It is located on the eastern slope of the ground elevation Laskomer (632 m a.s.l.) at the right side of the Bystrica valley.

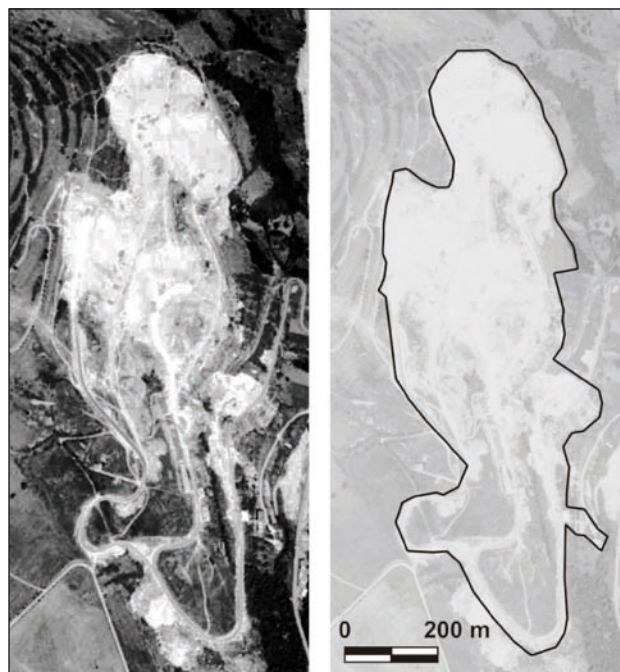
**Fig. 11.** Aerial photograph of the Kostiviarska quarry at the beginning of the 1970s, graphically compiled according authors Hronček et al. (2009, left) and graphically elaborated ground plan of the Kostiviarska quarry at the beginning of the 1970s (right).

In the second phase at the beginning of the 1970s (Fig. 11) the limited traverse of the area took an elliptic plan with some spurs where technical works were located. The quarry area was 1 300 m long in the north-south direction and 400 m wide in its widest place. The total devastated area with relicts after quarrying was 38.68 ha. The side quarry in the northern part of the area was 325 m long and 360 m wide and it was divided into 4 mining plates. Each of the plates was accessible by individual road which the lorries used to transport the produced rock for processing in the southern part of the area. In addition to the paths in the quarry and the technical works, also the loading station of the cableway in the eastern part of the quarry may be well identified. Permanent grassland – grazing – grew in the surrounding of the quarry, where the tree stock meshed, particularly in the north-east and south-east near the Bystrica river flat.

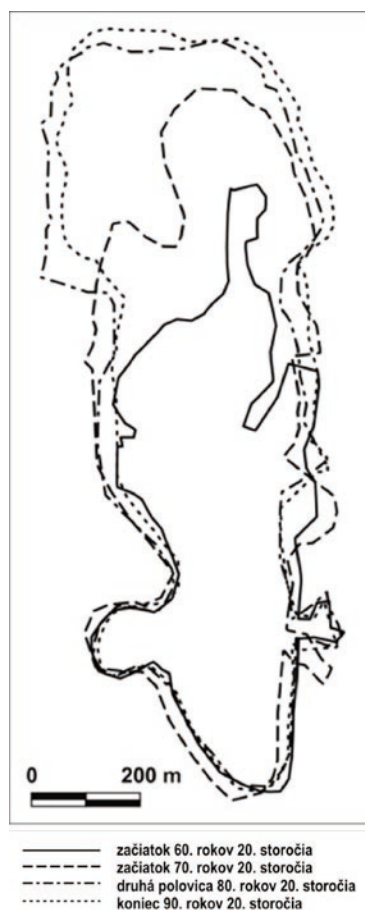
**Fig. 14.** Comparison of areal growth of the Kostiviarska quarry in the second half of 20th century according to polygons of particular analysed periods.

During the analysis of the aerial photographs of the first phase from the beginning of the 1960s (Fig. 14) the Kostiviarska quarry was one of the largest quarries of the Zvolenská kotlina basin and reached gradually the dimensions of a large quarry. Its area was 25.57 ha. The shape of the emerging quarry depended on the layer shape and position on the eastern slope of the right side of the Bystrica valley. In the next phase at the beginning of the 1970s the area extended in the north direction and so did the area of the quarry. The borders of the southern part of the area, where the technical works, service buildings, access road system and the loading station of the cableway were located, did not change considerably during the examined period. At the beginning of the 1970s after a decade of an intensive quarrying, the total quarry area was 38.68 ha, that is 51.3 % increase, i.e. by 13.11 ha. In the next phase the intensive mining continued mainly in the vertical direction into the depth of the layer and moved slowly in the horizontal north-west direction. In the 2nd half of the 1980s the quarry area devastated by the intensive quarrying reached 47.11 ha, that is 22 % increase, i.e. by 8.48 ha. The last research phase from the end of the 1990s is characterized by the decrease of raw material mining for the cement works at the end. As a result, the shape of the devastated quarry area did not change considerably, but its area was reduced. The reducing of the area resulted

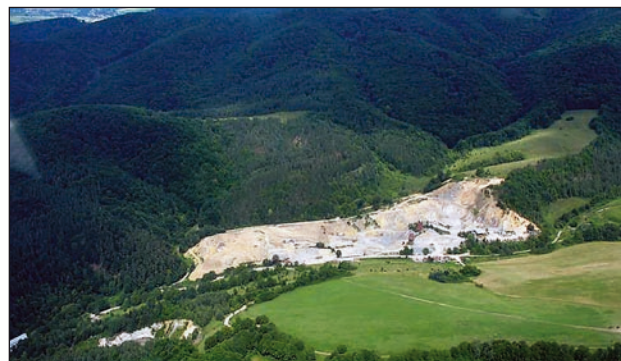
**Fig. 15.** Aerial view on the Iľiaš – Okružle quarry, located in the Dolina valley in 2009. Photo Z. Filadelfi.

The quarry is located about 0.5 km in the east from Iliaš on the southern slope of the ground elevation Okružle (485 m a.s.l.) on the right side of the Dolina valley (Fig. 15). The quarry was opened in the Middle to Upper Triassic dolomite bed with the stock prognosis estimated to 600 000 m<sup>3</sup> (Polák et al., 2003; Polák, ed., 2003). The layer was opened by the former local agricultural cooperative in the 1970s. Recently, the MHRČ s.r.o. company from Banská Bystrica has performed the mining activities and the annual mining volume is between 250 000 and 300 000 tonnes.
