Registration and evaluation of newly evolved slope failures in Prešov and Košice regions in 2010

PAVEL LIŠČÁK¹, PETER PAUDITŠ¹, LUBOMÍR PETRO¹, LUBICA IGLÁROVÁ¹, PETER ONDREJKA¹,
IVAN DANANAJ¹, MARTIN BRČEK¹, IVAN BARÁTH¹, MARTIN VLAČIKY¹, ZOLTÁN NÉMETH¹,
LUBICA ZÁHOROVÁ¹, MIROSLAV ANTALÍK¹, MARTIN REPČIAK¹ and DUŠAN DROTÁR²

¹State Geological Institute of Dionýz Štúr, Mlynská dolina 1, 817 04 Bratislava, Slovak Republic

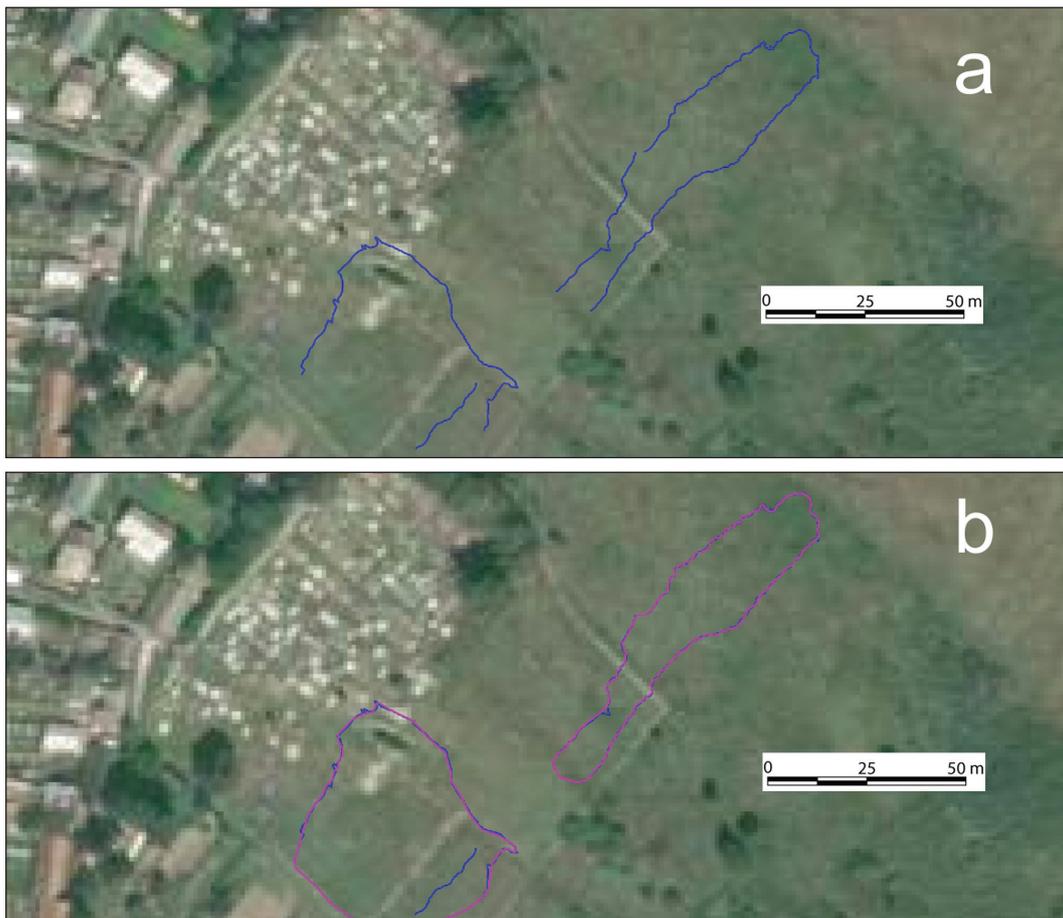
Fig. 1. Accuracy of GPS measurements – class 1. a – rough line of GPS measurement; b – the same line smoothed.

Class 1: Data recorded with the highest possible precision of the instrument, with an average error of up to 1.5 m, assuming the availability of signals from more than 5 GPS satellites and additional signals from the European Geostationary Navigation Overlay Service (EGNOS). The accuracy of orientation was close to 0.5 m level. Thus, the recorded data are virtually “scaleless” and can be used in accordance with arbitrarily precise map data, including cadastral maps of the largest scales, for example in quantification of damage on individual lots, without the need for additional geodetic survey. With such accuracy **173 slope deformations** were recorded. An example of a contour line retrieved from a GPS measurement is in Fig. 1a, the same object with a smoothed line is in Fig. 1b.

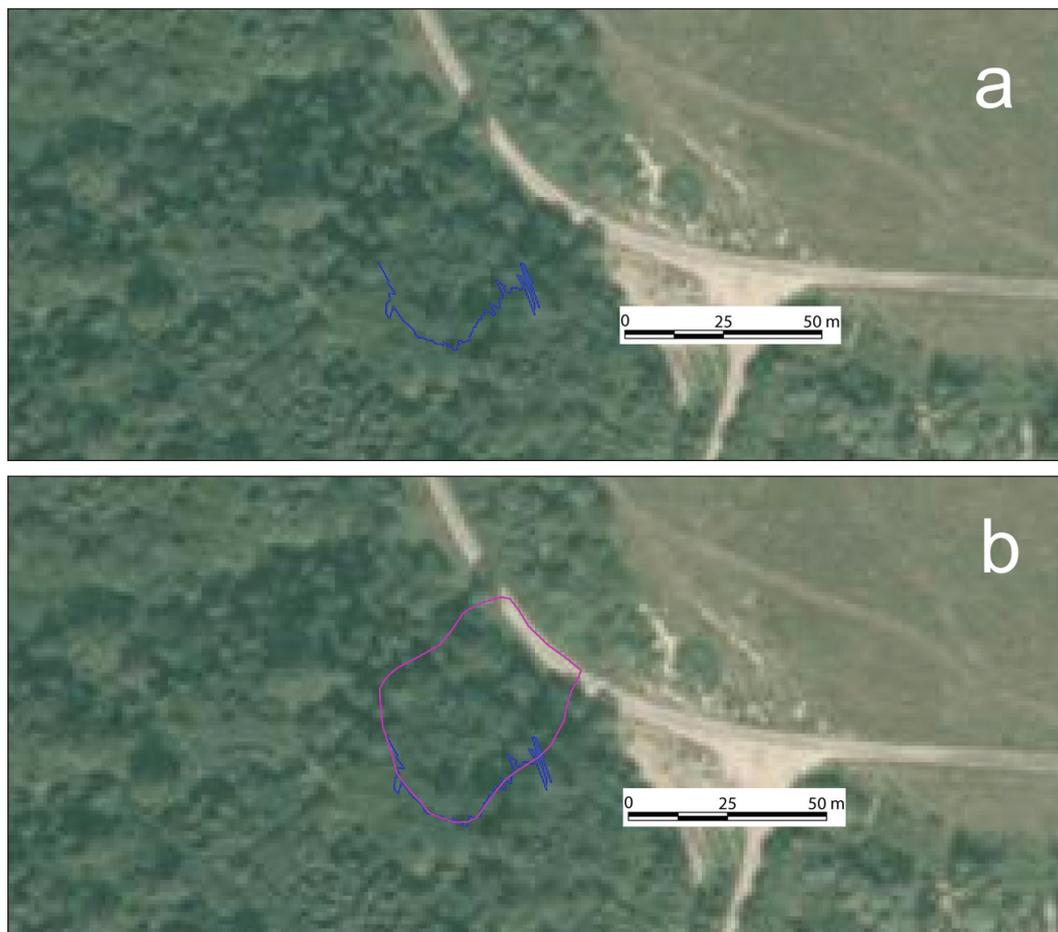
Fig. 2. Accuracy of GPS measurements – class 2. a – rough line of GPS measurement; b – the same line smoothed.

Class 2: Data with relatively high accuracy with an error ranging from 1.5 to 7 m. The error was caused in most cases due to unavailability of sufficient number of satellites due to improper daytime (usually around noon), due to dense vegetation or improper configuration of terrain (steep slopes with a strong signal shielding effect). The leap in accuracy compared to the class 1 was mainly due to the unavailability of the signal from the EGNOS satellites. The data are compatible with the map at scales smaller than 1 : 2 000. All in all we have recorded **227 slope deformations** of this quality. An example of a contour line retrieved from a GPS measurement is in Fig. 2a, the same object with a smoothed line is in Fig. 2b.

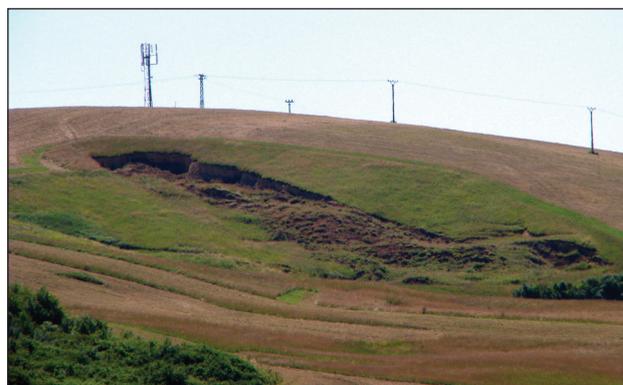
Fig. 3. Landslide Lužany pri Topli.

Photographic documentation was performed by digital cameras of different brands; minimum requirement for quality resolution was 3.2 Mpi. After a refinement of a "raw" Photo-catalogue we have got the set of 2 380 photos of 544 sites (Fig. 3).

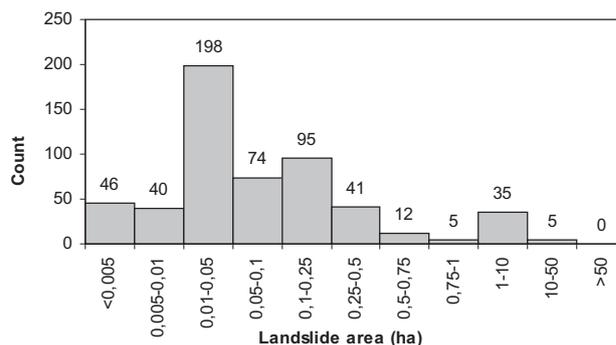
Fig. 4. Distribution of slope deformations according to their area.

The largest landslide was identified in Ďačov, followed by Močarmany, Prešov 2 (Pod Wilec Hôrkou), Kamenica 2, Varhaňovce 1 and Varhaňovce 2, Vyšný Čaj 3, Kapušany, Nižná Hutka 2 and Prešov 1 (Horárska). Tab. 3 shows the count of slope deformations in the affected regions and districts and their total area, Fig. 4 shows the distribution of slope deformations according to their area.

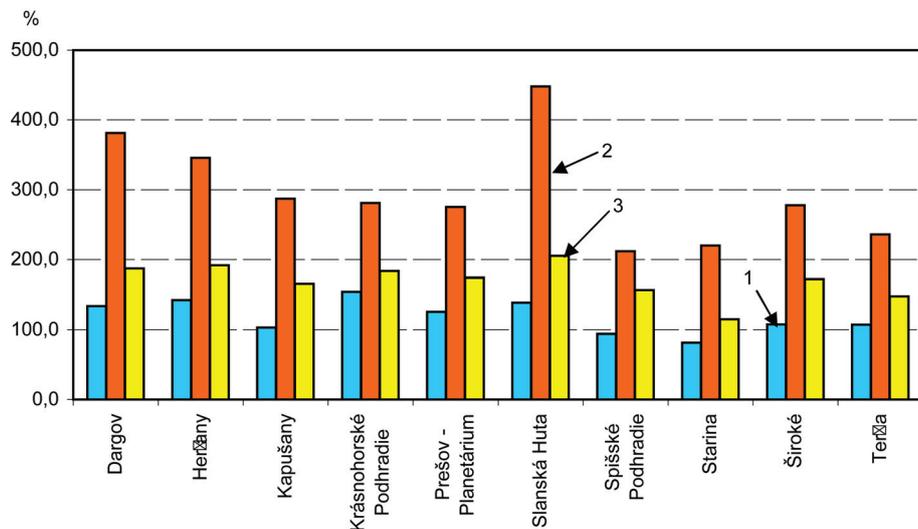
Fig. 5. Ratio between rainfall totals of the first half of 2010 and long-term mean in selected time intervals. 1 – months January to April; 2 – month of May; 3 – months January to June.

Overall, during the first half of 2010 there was recorded in the region of the Eastern Slovakia on 15.0 (Starina) to 105.6 % (Slanská Huta) rainfall total greater than the mean of the years 2001 – 2009. Those conditions can be considered as highly negative in terms of the impact on the stability of slopes.

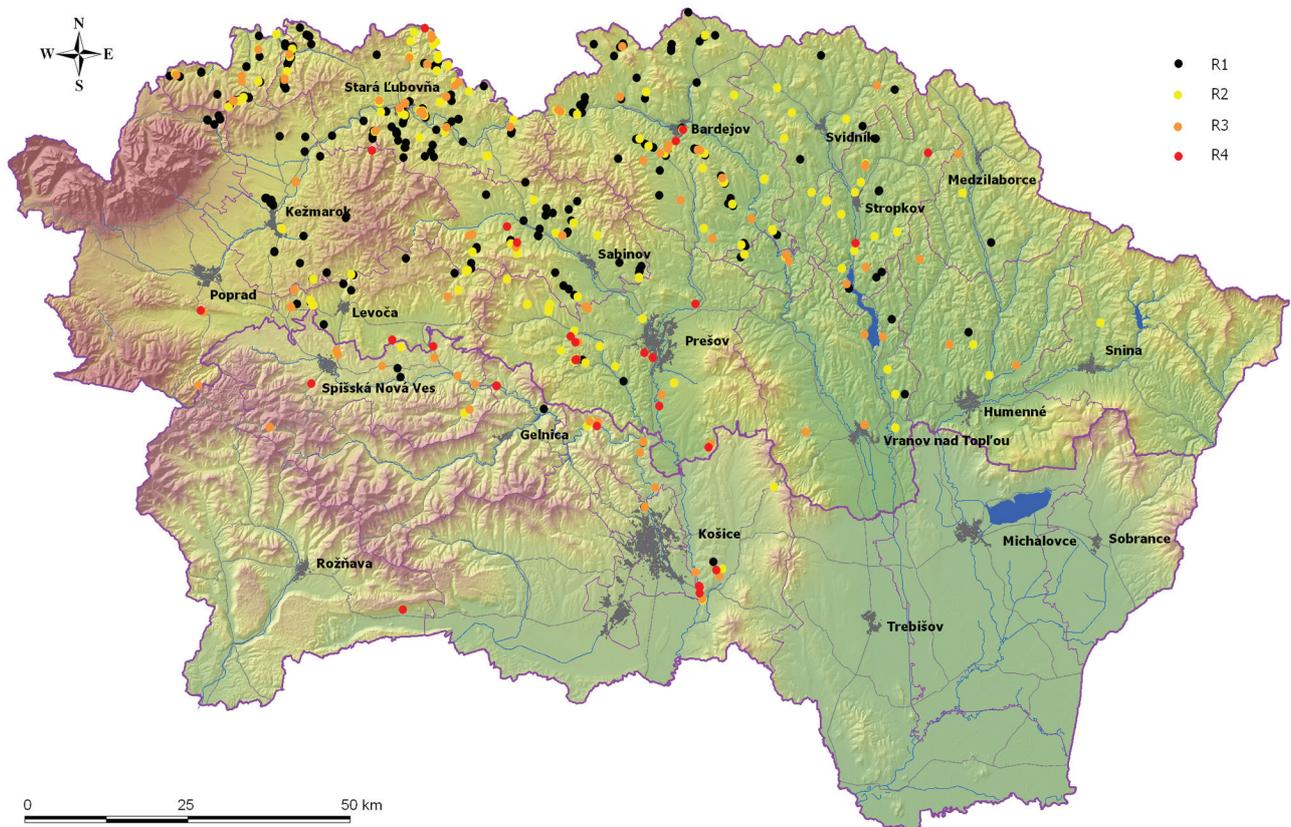
Fig. 6. Landslides activated in May/June 2010 in the Košice and Prešov regions. R1, R2, R3 and R4 are categories of socio-economic relevance.

The whole set of registered slope deformations was divided in accordance with the **purpose-made categorization** of socio-economic significance (threat to life and property) and consequent risk of landslide on the scale recommended by the European Commission for multirisk evaluation (Marzocchi et al., 2009) as follows:

– **moderate (R1)**: social, economic and environmental damages are marginal – **273 slope deformations**;

– **medium (R2)**: minor damages to buildings, infrastructures and environment are possible. No significant effect on people, functionality of buildings and economic activities – **151 slope deformations**;

– **high (R3)**: concern exists on peoples' safety. Functional damages to buildings and infrastructures are possible as well as interruption of the economic activities and relevant damages to the environment – **98 slope deformations**;

– **very high (R4)**: expected damages include casualties and injuries, serious damages to buildings and infrastructures, destruction of the environment and of the socio-economic activities – **29 slope deformations**.

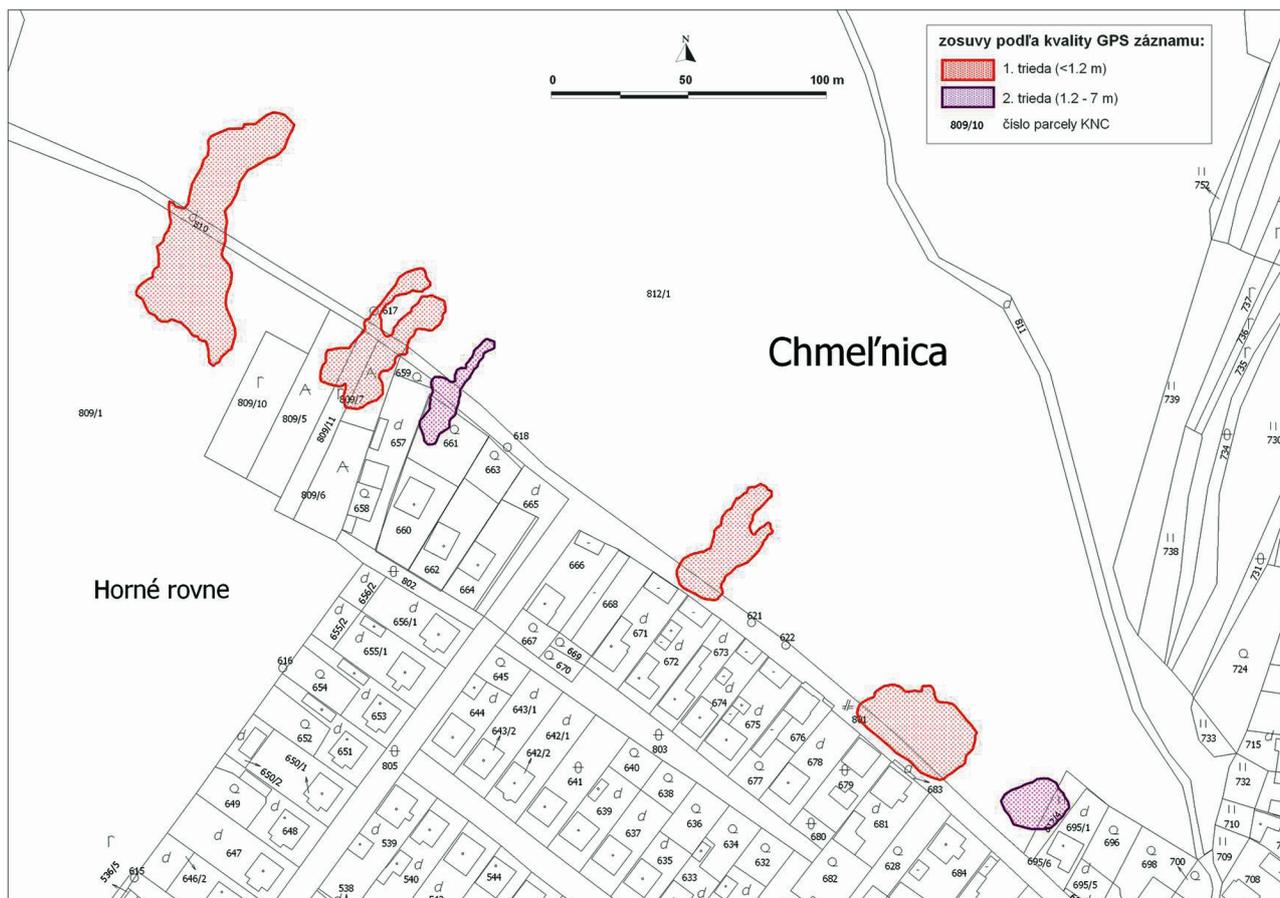
Fig. 7. Presentation of "scaleless" records of slope deformations on cadastre map of Chmeľnica Municipality.

The most important benefit of the inventory is the “instant” information on the status and impact of slope deformations, incurred, or reactivated in May and June 2010 due to climate extremes. The inventory, categorization and update of the current status of landslide sites enable the government and local authorities to lead effectively the necessary funds for exploration and remediation of such territories. The way of data collecting and processing, “scalelessness” of topographic information, registration of damaged or endangered buildings allow to incorporate this accurate documentation into the land use planning documents, regardless of the detail of the processing and geodetic survey (cadastral maps of lots C and E categories, geometric plans, detailed maps of engineering networks utilities, different land maps, documents of Territorial System of Functional Arrangement, forestry maps, etc.). Thus, based on a compliance with the cadastral map it is possible to quantify precisely the size of a damage to a lot with a possibility of identifying the owner etc., what is such an important input for the documentation for insurance claims, identification of the extent of damage to gas pipelines, water pipes and so on. An example of slope deformations presentation on cadastre groundwork is shown in Fig. 7.
