Comparison of two model environmental burdens with massive light non-aqueous phases liquids (LNAPL) pollution – the extent of pollution identified by geological survey vs. reality uncovered by remediation

Key words: remediation, light non-aqueous phases liquids, locomotive depot, environmental burden

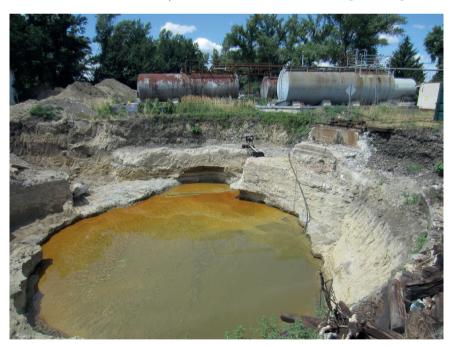
Fig. 4. LNAPL in excavation pit at locality Leopoldov depot.

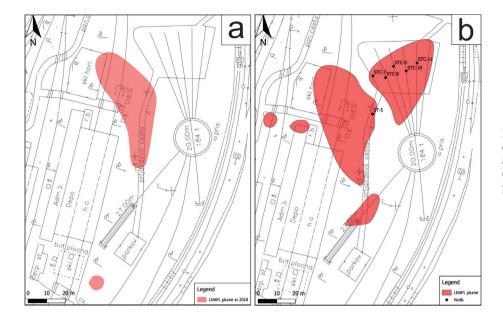
Fig. 5. LNAPL plume at model localities identified by remediation activities – a) Leopoldov depot (Tupý et al., 2022), b) Štúrovo depot (Urban et al., 2021).

The remediation thus verified the pollution by LNAPL on an area approximately three times larger than originally expected (Fig. 5). The work of Macek and Milička (2021) evaluates the nature of pollution regarding its degradation and the result is the conclusion that the pollution comes from several different sources. Despite the fact, that the depot has been out of operation for more than 10 years, one of the collected LNAPL samples showed no obvious signs of degradation.
