1. History of Systematic Research of Slope Failures in Slovakia

FRANTIŠEK BALIAK¹, PETER WAGNER² and PAVEL LIŠČÁK³

Abstract. Due to much dissected morphology and complicated geological setting the territory of the Slovak Republic is affected by abundant slope deformations that cause significant harm the whole society. The origin and evolution of slope deformations may be natural, but very often they result from human activities, especially construction activities. The increasing number of landslide accidents in the previous century resulted in a necessity of a systematic study of this phenomenon with the goal of their registration, knowledge of the causes and progressive elimination of adverse consequences. In the article the authors present a brief overview of the history of the study of slope movements in Slovakia, demonstrating the crucial importance of the catastrophic Handlová Landslide from the break of 1960/61 for further systematic research of slope deformations; they outline the main results of the study in the last fifty years and indicate the current issues of the slope deformations research at present.

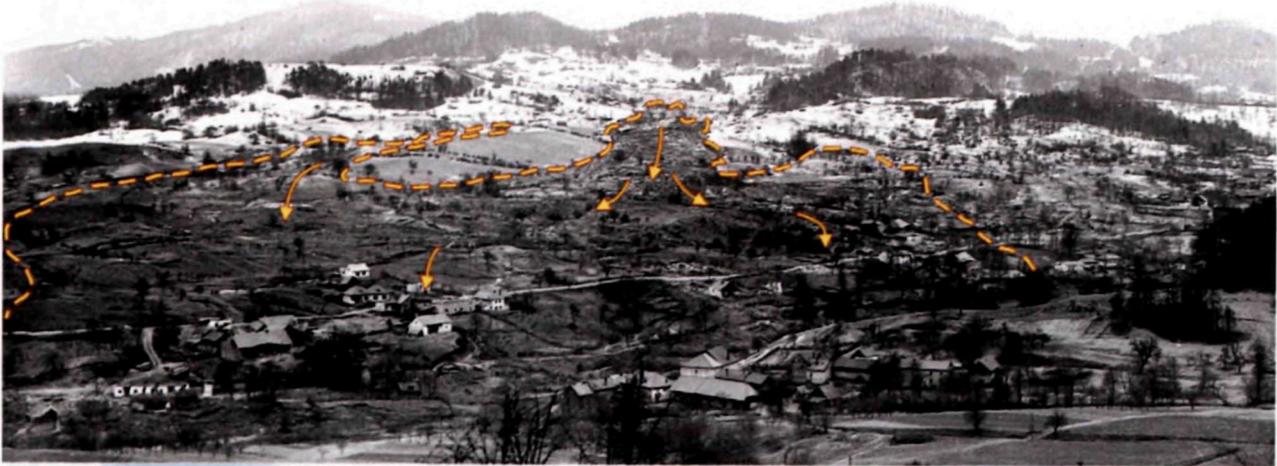
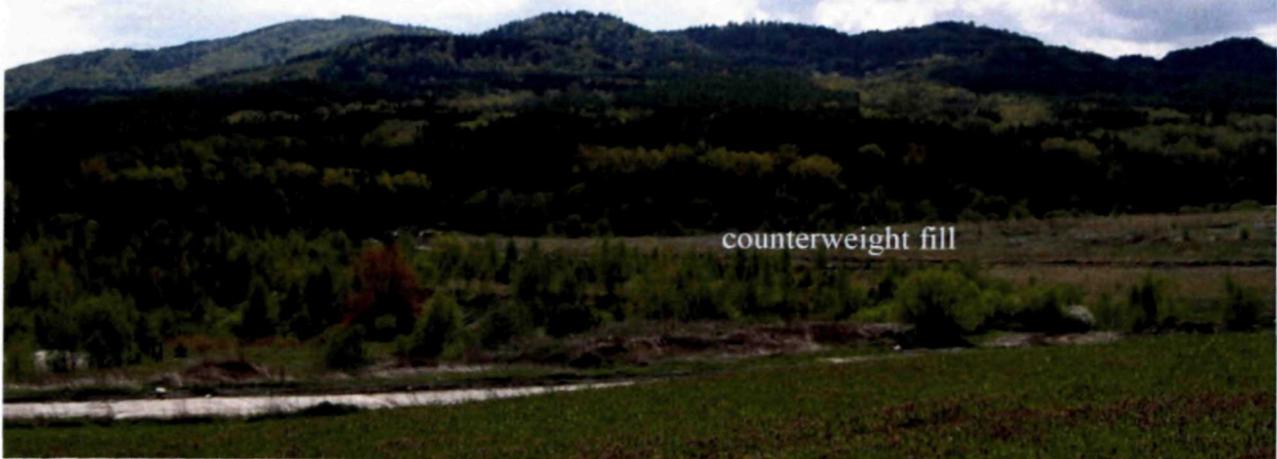
Fig. 1.1 View of the Handlová Landslide. A - photo of 1961; B - recent photo, corrective measure - counterweight fill

The Handlová catastrophic landslide was active from 11/12/1960 till 30/5/1961. In the head area the landslide started with 80 to 110 m wide earth flow, with tributary slide they joined to a huge landslide with a width in the accumulation area of 1200 m (Fig. 1.1, Baliak & Stríček, 2012). The thickness of the slip materials in the head area was 7 m, in the accumulation zone up to 30 m; total cubic capacity of slide reached about 20 million m³ (Záruba & Mencl, 1969).

The landslide movement had the greatest intensity from 22/12/1960 till 20/01/1961, when the movement rate reached up to 6.3 meters for 24 hours. Horizontal displacements of the mass in the central part of the landslide reached 240 m, in the accumulation part 22 m.

The consequences of the landslide were catastrophic – 150 residential homes were destroyed along with a section of the State Road 1/50 of the length of 2 km, branch Handlová water-line and several lines of high voltage (Nemčok, 1982). The Handlová Landslide is still considered the greatest natural disaster in Slovakia, induced by slope movement (Baliak & Stríček, 2012).

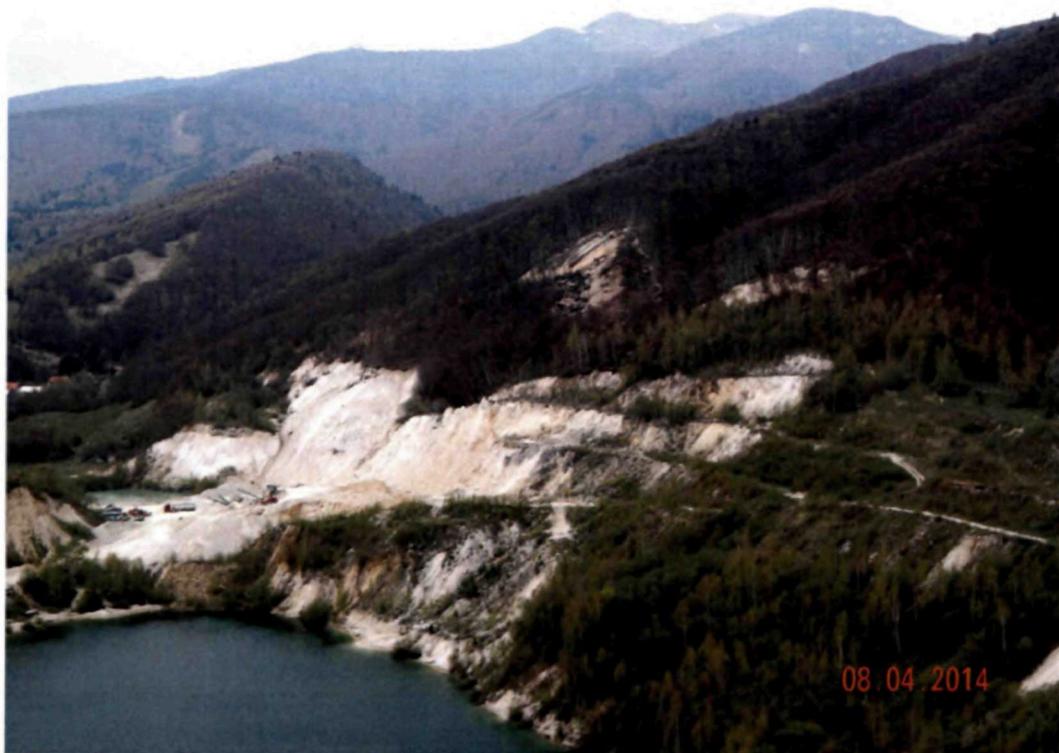
Fig. 1.2 View of the Kraľovany Rockslide (Photo by Žilka, April 2014)

A true "hot issue" is the rockslide Kral'ovany in northern Slovakia, which has been activated in the active limestone and dolomite quarry in spring 2013, and become one of the most spectacular slope failures in the modern history of Slovakia, both in terms of the dimensions as well as the risk to society (Fig. 1.2). The slide masses reaching a volume of more than 2 million m³ pose a risk for recent infrastructure and lives and property of inhabitants and visitors to the site. Moreover, a route of the most important transportation artery - motorway D1 - has been designed in the very place of the accumulation zone of the rockslide. In addition to classical exploration of the a monitoring was implemented at the site involving on terrestrial survey and GNSS methods, land-based and aerial photogrammetry and laser scanning (Liščák et al., 2014).

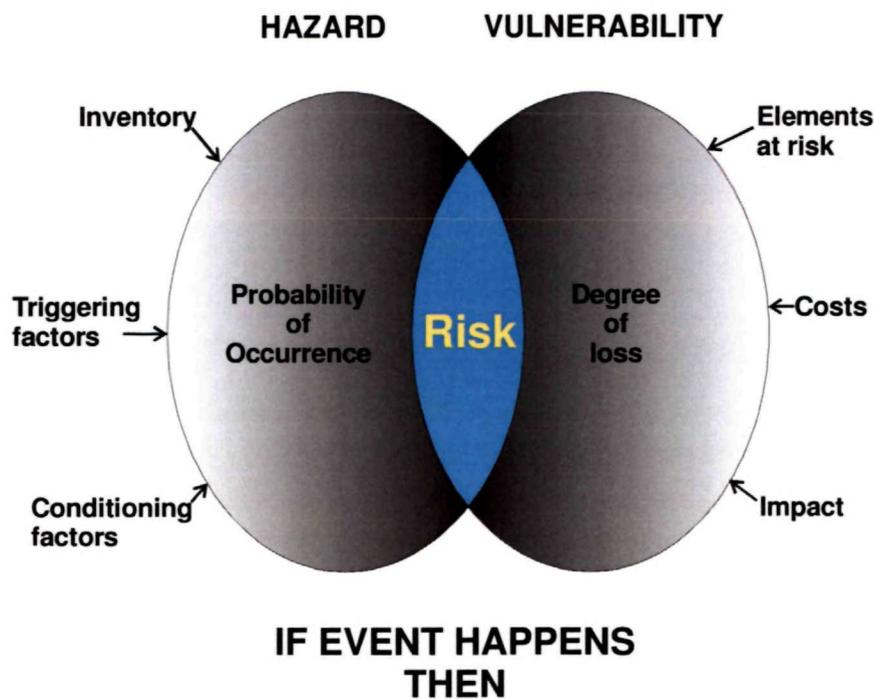
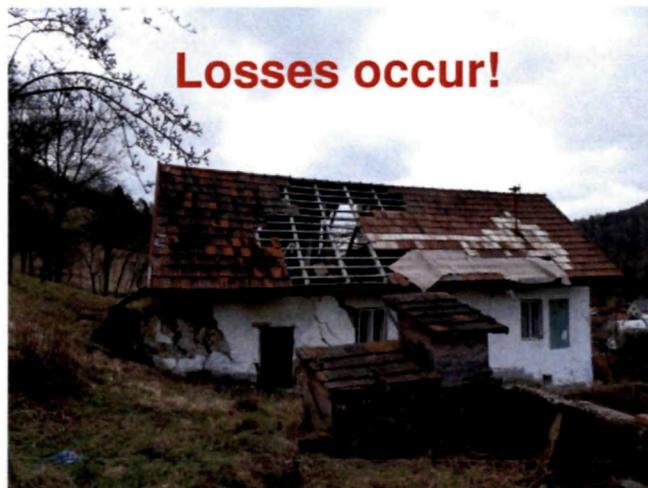
Fig. 1.3 Graphic depiction of the landslide risk assessment methodology (modified according to Alexander, 2002, in Petrydesová, 2012). Photo of destroyed house in the Červený Kameň village, Liščák, 2013

Any activity carried out in jeopardized environment is closely connected with risk, which can be expressed as a probability of occurrence of an event with potentially harmful consequences in form of loss and damage to natural environment, constructions, life and property (Ondrášik, Gajdoš, 2001). In other words risk is a product of hazard and vulnerability (Fig. 1.3).

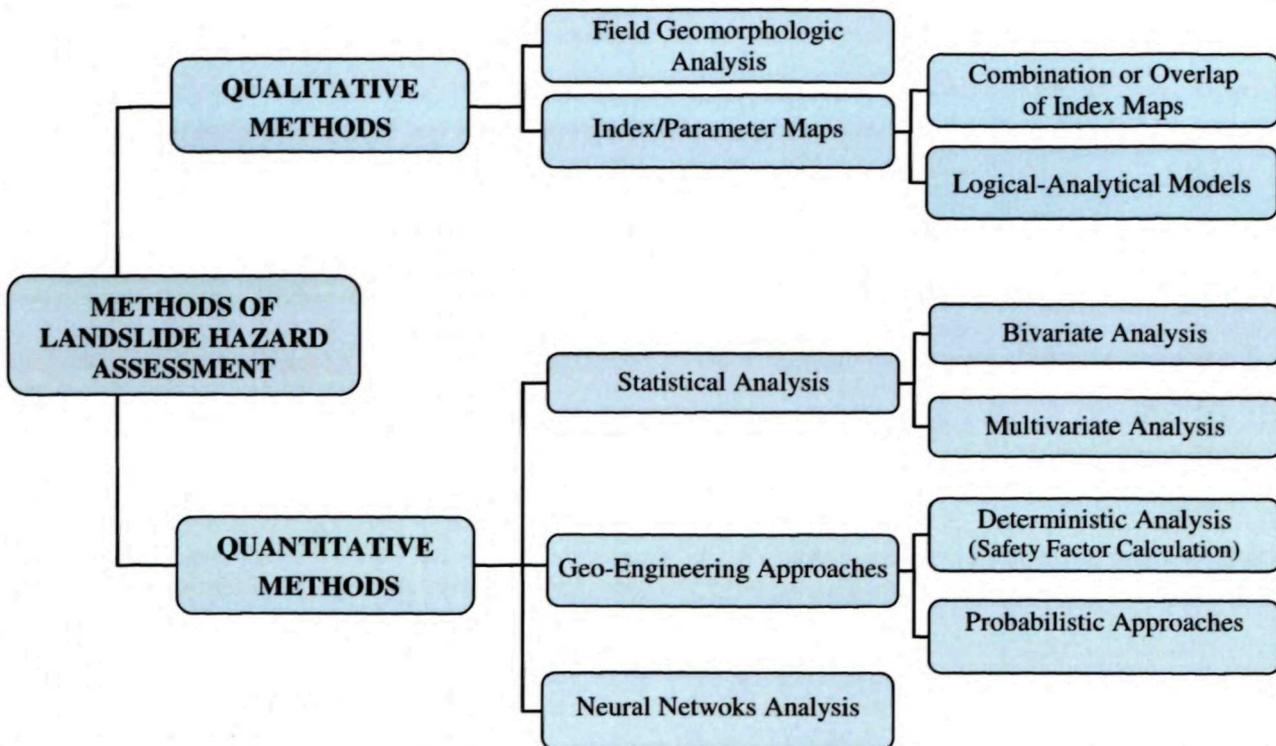
Fig. 1.4 Overview of the methods of landslide hazard assessment (in Petrydesová, 2012, modified after Aleotti, Chowdhury, 1999)

Recently there are plenty of methods, which assess the landslide hazard; they can be roughly classified into five groups (Carrara et al., 1992):

- geomorphological hazard mapping;
- analysis of landslide inventories;
- heuristic or index based methods;

- functional, statistically based models;
- geotechnical or physically based models.

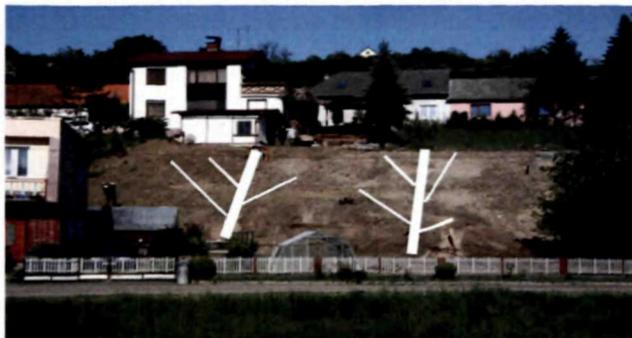
Fig. 1.5 Configuration of stabilization-drainage ribs at the site Krupina

The GIS database, besides the obligatory characteristics of slope failures contains also their division into 4 categories according their socio-economic relevance. This classification provides the Ministry of Environment an essential tool for aiming engineering geological surveys and corrective measures into the most endangered sites. All-in-all, 58 slope failures at 36 sites were selected for engineering geological surveys, which were realized in extremely short time period of about 3 winter months on the break of 2010/2011. Based on the data retrieved from the surveys corrective measures were implemented on the most significant sites in 2011-2012 (the first stage of remediation), the second stage is planned for the summer 2014. In addition to the landslides of 2010, SGIDŠ workers registered in the following years numerous new landslides, for instance in 2011, 21 from the 36 registered occurred in the territories, classified by “Atlas” (Šimeková et al., 2006) as stabile (Petro et al., 2011). Some of them were even declared emergency landslides (Fig. 1.5, Dananaj et al., 2012, Ondrejka et al., 2012).
