## 7. Main Results of the Slope Deformations Monitoring

**Abstract:** The presented contribution gives brief information on the development and status of the slope deformations monitoring in the Slovak Republic under the umbrella of the project Partial Monitoring System - Geological Factors. In addition to basic information the attention is given to study cases of monitoring of various types of slope failures and to the research achievements. At the same time the authors present the current state of knowledge in developing of Early Warning Systems for landslides.

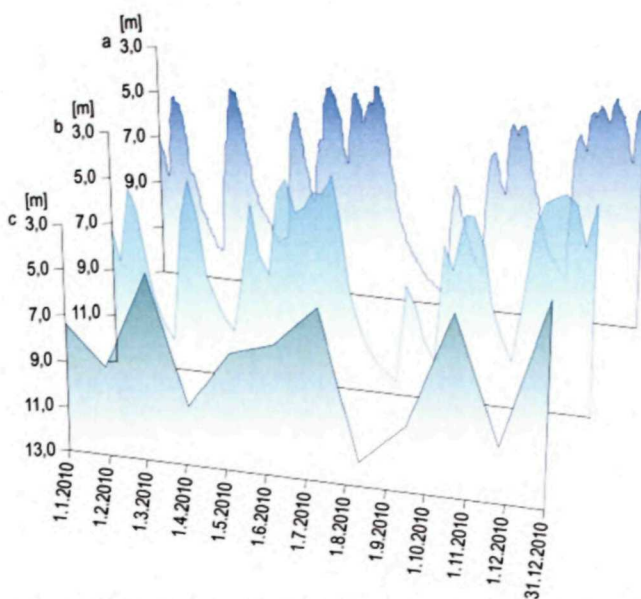
Fig. 7.3 Comparison of results of monitoring of groundwater table level with different frequency in borehole JM-6 at the landslide site Dolná Mičiná. a - continuous measurements using automatic piezometers, b - weekly frequency, c - monthly frequency of measurements

The quality of information obtained from the automatic level gauges is considerably higher than that of the conventional measurements performed at longer intervals. Fig. 7.3 shows a comparison of continuous measure-

ments with the results obtained during cycles of field measurements carried out by observers (with weekly and monthly frequency). The above example clearly docu-

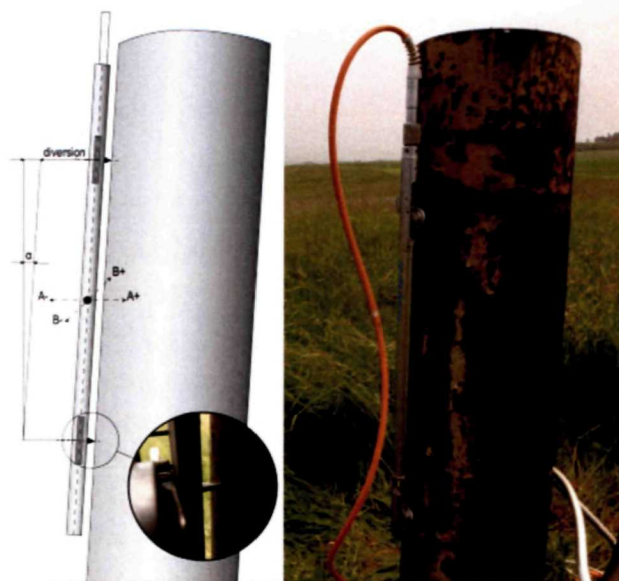
Fig. 7.8 Principle of measurements of change in angle of geodetic pillars by inclinometric probe

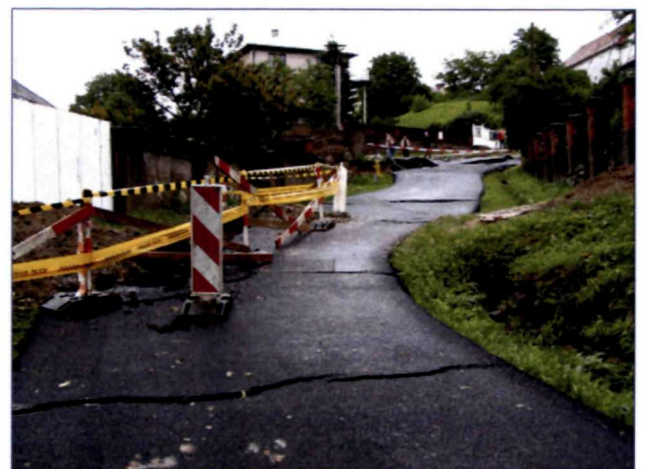
Fig. 7.11 Village road destroyed by landslide

The first signs of reactivation of landslides were reported from 1 to 4 June 2010. Finally, they led to the massive failures in housing, water, gas, power lines, roads and sanitation (29 houses had to be demolished, Fig. 7.11).

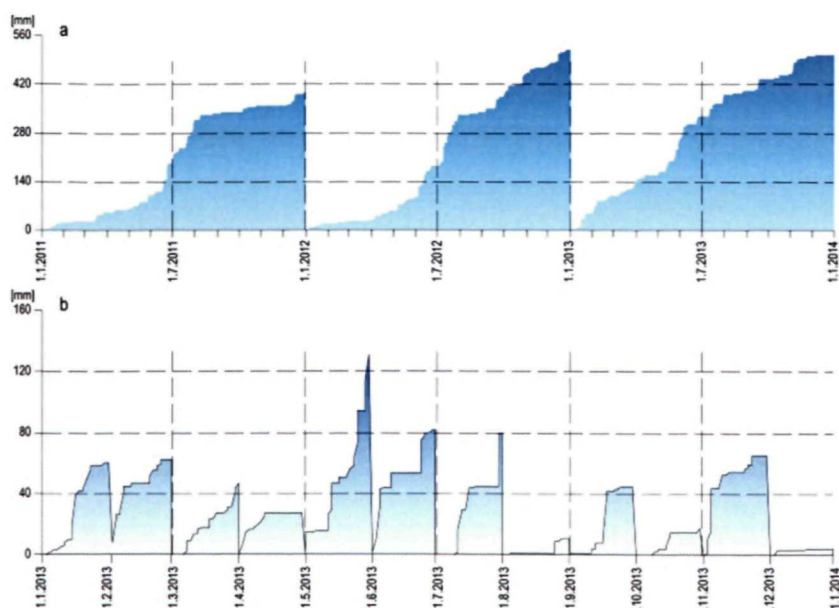
Fig. 7.12 Precipitation totals of the SHMI station Čaňa. a - cumulative yearly precipitation totals in the years 2011 to 2013, b - cumulative monthly precipitation totals in the year 2013

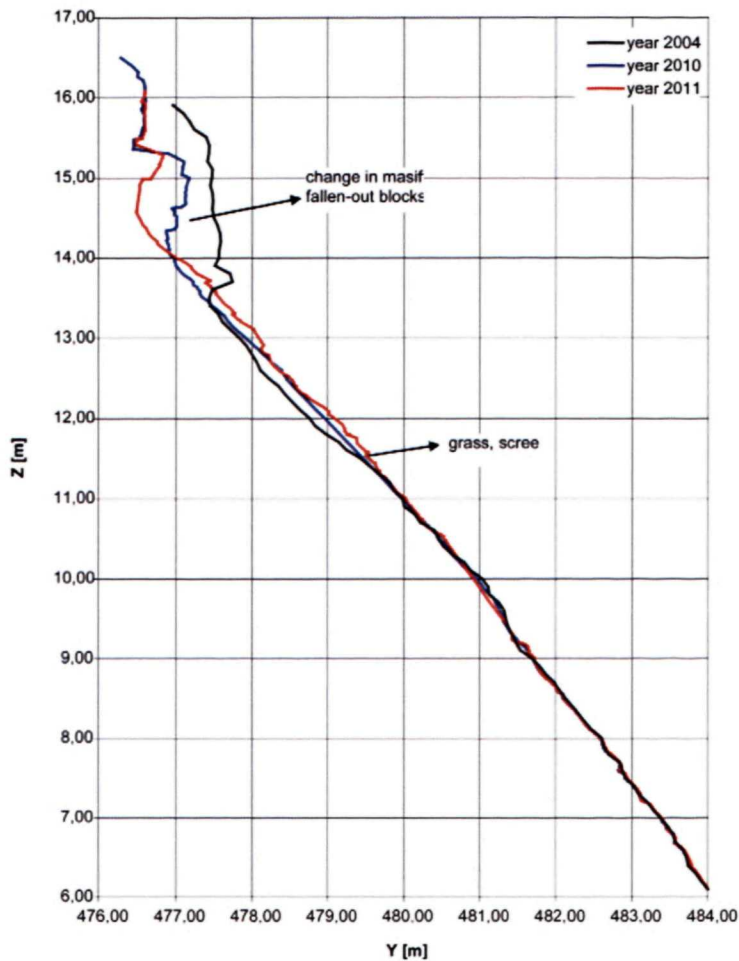
Fig. 7.19 Profile in the stationing -17,5m from the years 2004, 2010 and 2011

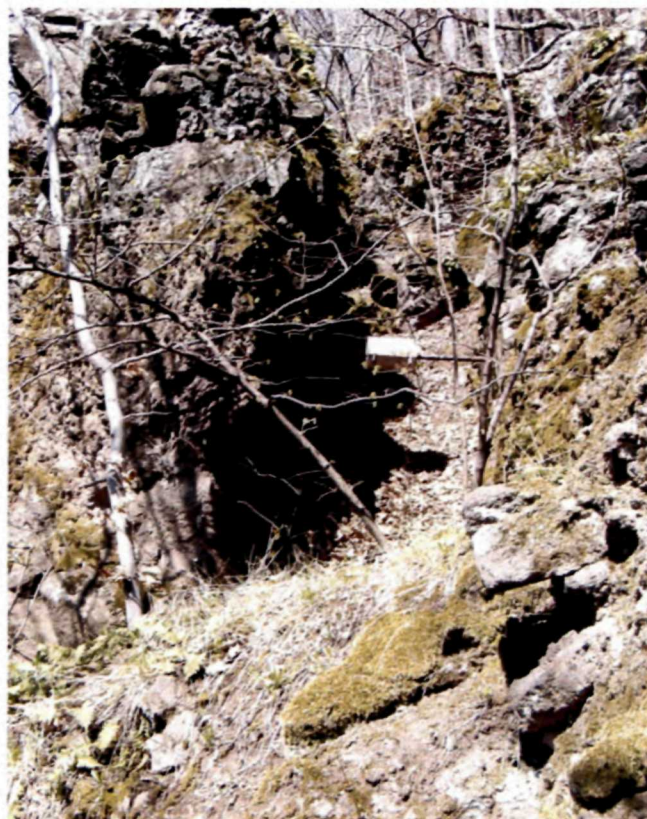
Fig. 7.24 Dilatometer TM-71 (KK-1) installed in the open crack between two (bottom and top) blocks at the western margin of the lava flow of the stratovolcano Střechový vrch

The dilatometers' reading is done visually with a frequency of 1-7 times per year. By the end of 2013 the number of readings with KK-1, which measures relative displacement between two blocks (the lower and the upper) on the edge of the lava flow (Figs. 7.23, 7.24), has reached 99. Since 1995 on the dilatometer KK-2 (Figs. 7.23, 7.25) the total number of measurements at the end of 2013 has attained 77. The results of the measurements processing are graphs of displacement and rotation of individual blocks. Spatial displacement was evaluated with respect to relative position of the two dilatometers against monitored cracks. Eight, respectively three-year measurements showed a trend of blocks movement in all three axes (Petro et al., 1998; Figs. 7.26, 7.27). The most significant was the movement in the  $z$  direction (downward), which exceeded 3 mm (KK-1), and 1 mm (KK-2). Shear movement along the vertical axis and the opening of the crack (movement along the  $x$  axis) reached about 1 mm (KK-1). Measurements of rotations of both blocks did not show significant movements. Interesting is the correlation between bound in the rotation record of the dilatometer KK-1 in the XZ plane in the second half of 1999 (Fig. 7.27b) and strong earthquake in the Turkish city of Izmit ( $M = 7.8$ ) registered on 17/8/1999 (Košťák et al., 2007). The link between this earthquake and the fluctuations in the records of rotations was found in dilatometer TM-71 in several European locations. In 2000, because of the obvious link between the motions of the monitored blocks with active fault failure at the edge of the Slanské vrchy Mts., the site Košícký Klečenov was included among Slovak tectonic sites within the project COST 625 "3D monitoring of active tectonic structures". The measurements in 2005 were evaluated in the final report for the Slovak Republic (Petro et al., 2005). Since that year all the measured data have been processed using new software MSDilat (Stercz, 2004). By the end of 2013 the measurement results showed a long-term trend in both blocks. The most significant movements are of the sink character (movement in the  $z$  direction), which for 23 years has reached 10.93 mm (KK-1), and for 18 years 9.28 mm (KK-2). From the average rate of sink of 0.48 mm and 0.52 mm per year it is clear, that the upper block is sinking faster than the bottom one (Figs. 7.26, 7.27). The shearing motion along the cracks (in the  $y$  direction) reached a total of 4.07 mm, and 2.99 mm, respectively. Even in this case, the upper block moves faster than the bottom one. Different results have been found in the direction of blocks displacement along the  $x$  axis. While the crack opening

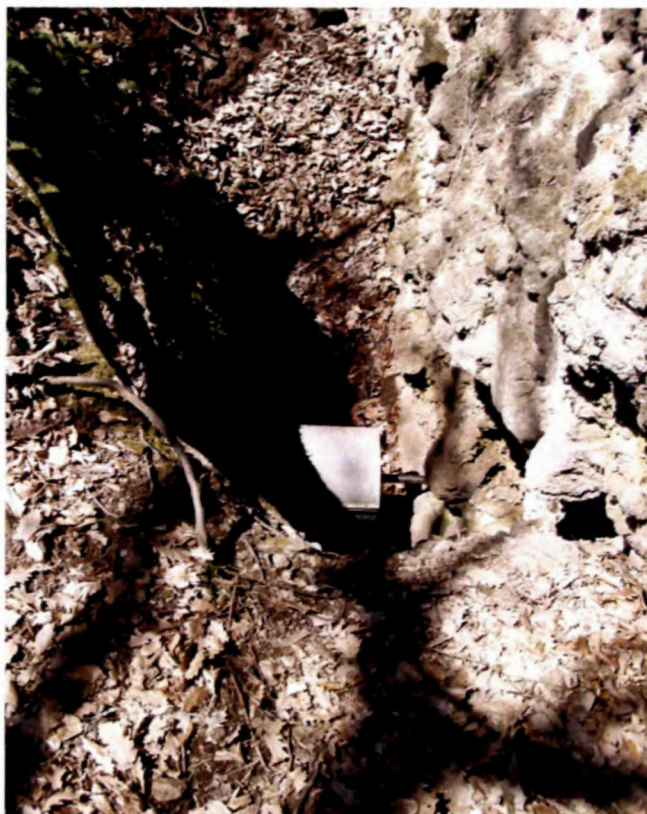
Fig. 7.25 Dilatometer TM-71 (KK-2) installed in the open crack between upper block and intact massif of the lava flow at the western margin of the stratovolcano Střechový vrch

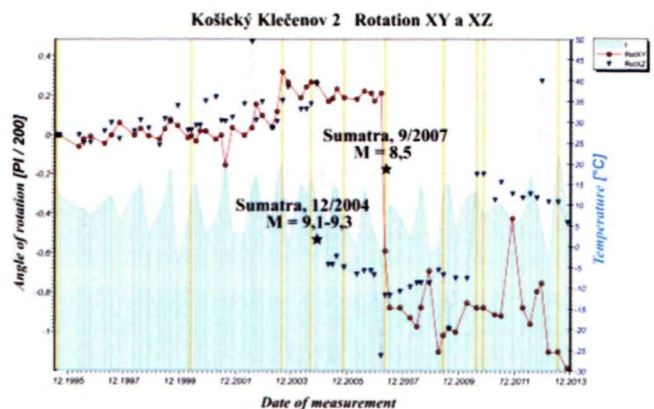
Fig. 7.27b Diagram of rotations in the planes XZ and XY recorded by dilatometer KK-2 installed in the open crack between upper block and intact massif at the site Košícký Klečenov for the period 1995-2013

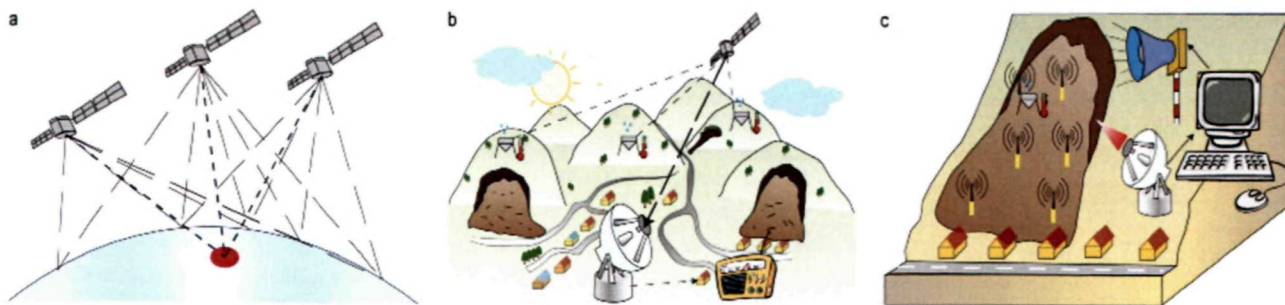
Fig. 7.28 Early warning system levels on landslides. a - global level, b - regional level, c - local level
