1. Influence of Monitored Environmental Burdens on Groundwater and Surface Water Quality – Case Studies

Key words: monitoring, environmental burdens, quality, groundwater, surface water, case studies

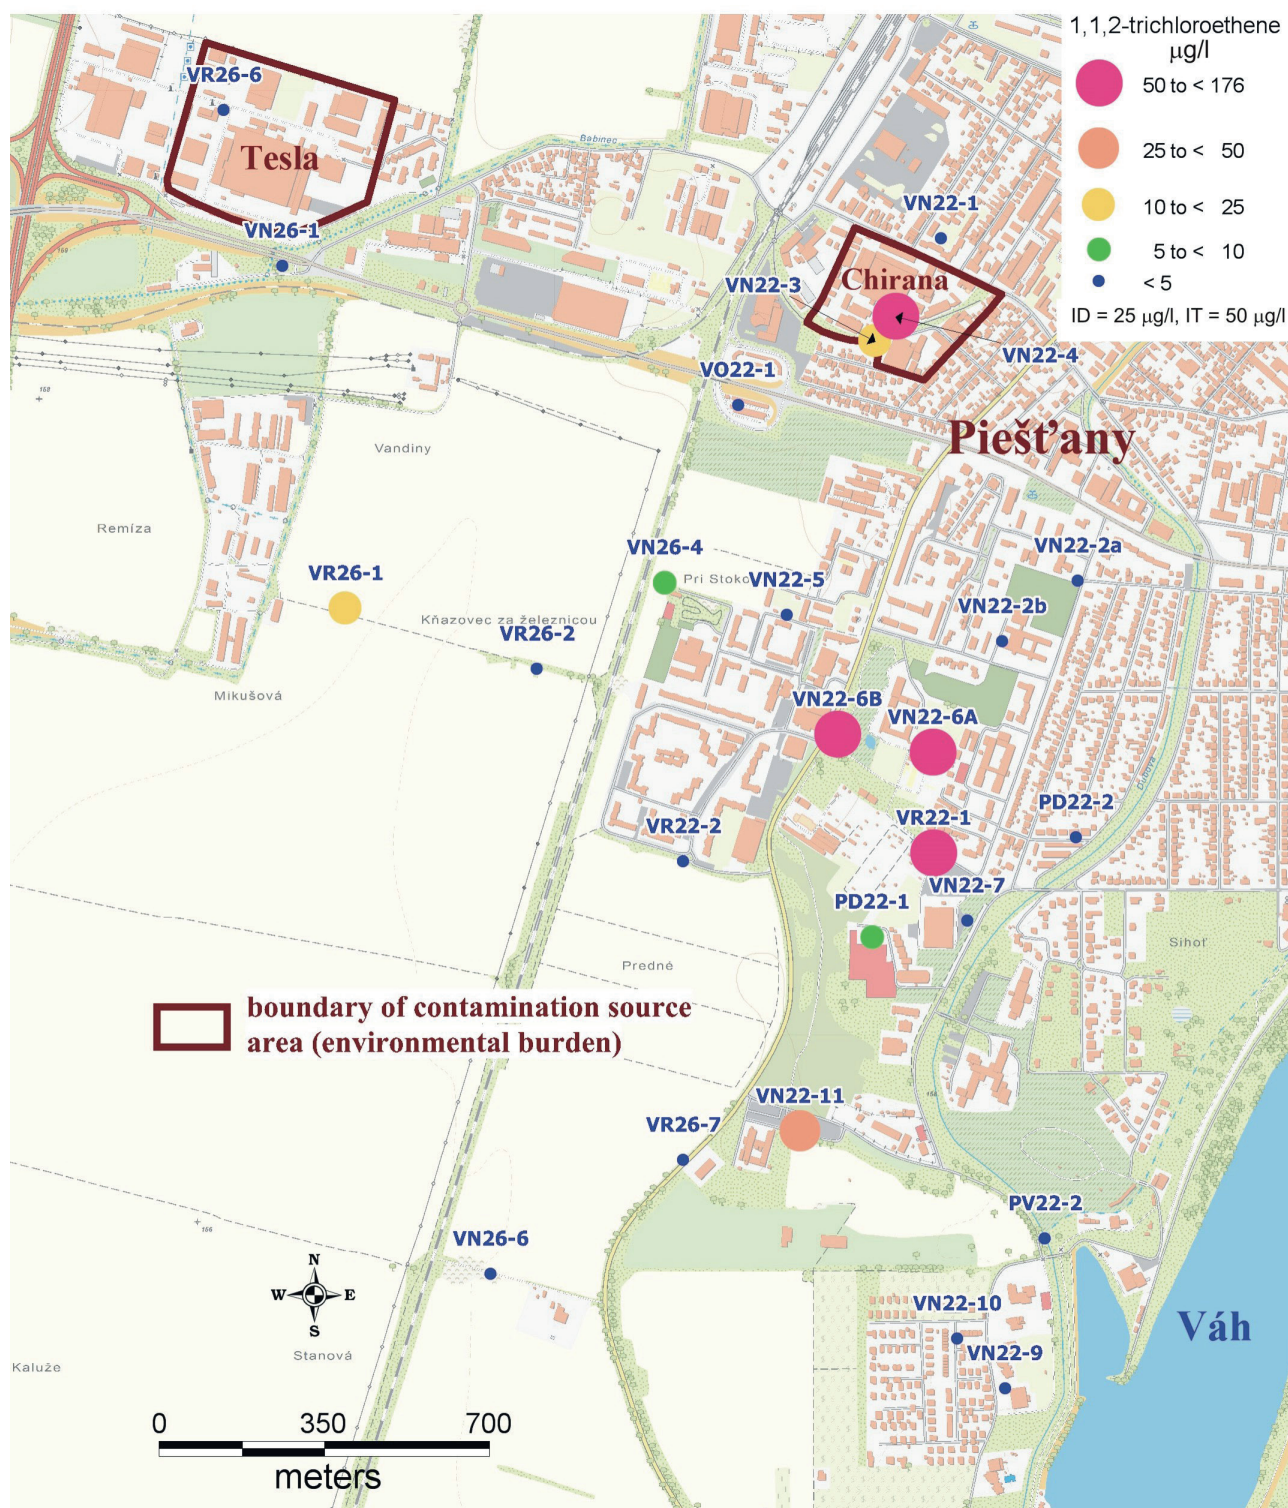
Fig. 1.6 Distribution of trichloroethene in groundwaters (median concentrations) – sites Piešťany – former factories Chirana and Tesla (Topographic background: ZBGIS®, The Geodesy, Cartography and Cadastre Authority of the Slovak Republic)

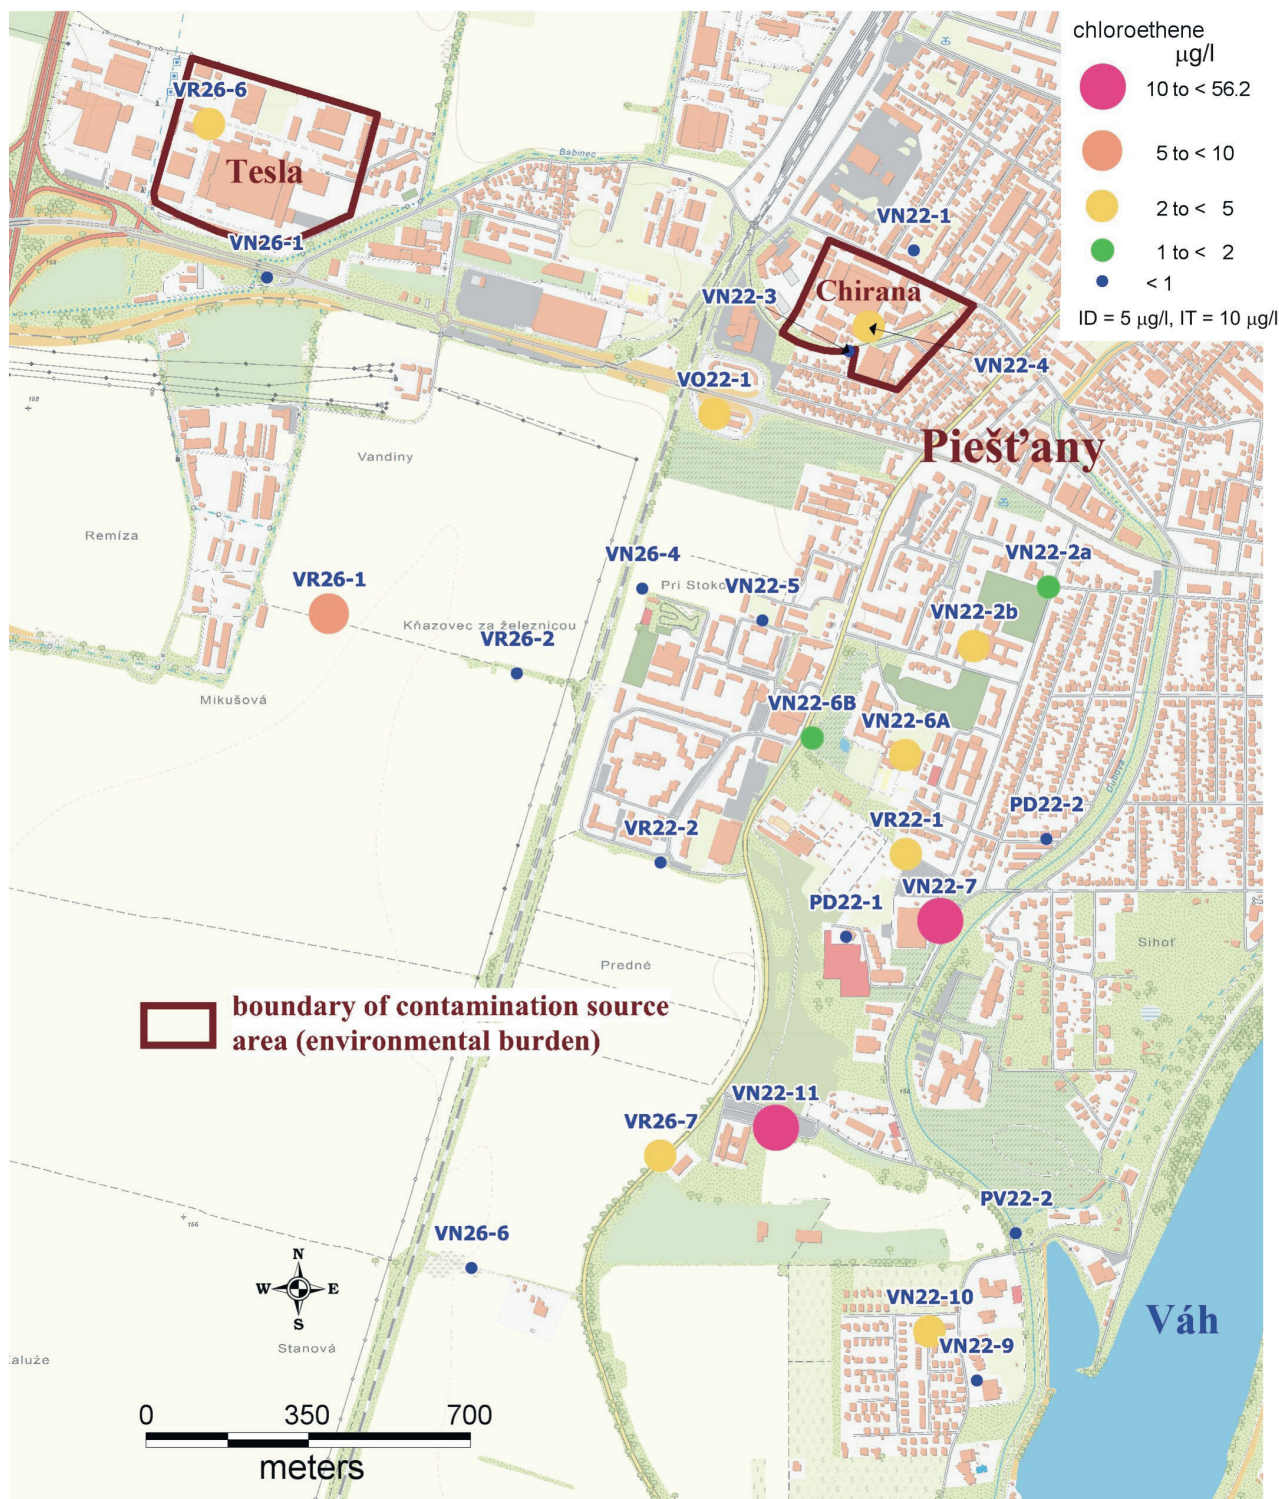
Fig. 1.7 Distribution of chloroethene in groundwaters (median concentrations) – sites Piešťany – former factories Chirana and Tesla (Topographic background: ZBGIS®, The Geodesy, Cartography and Cadastre Authority of the Slovak Republic)
